COASTLAND

Date: January 3, 2022
To: Andre Jadcowski, P.E., NCE
From: Jenny Melman, P.E.,
NASSCO PACP Cert. U-0819-70306761
Subject: City of Richmond
Keller Beach Sanitary Sewer CCTV Review
and Assessment Report

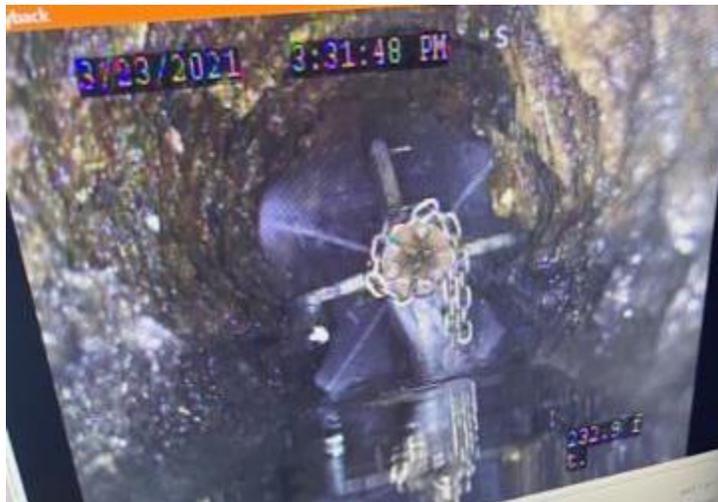
Figure 1. View of Keller Beach sewer pipe prior to cleaning. Hydro nozzle is in use. Chain flail is in view.

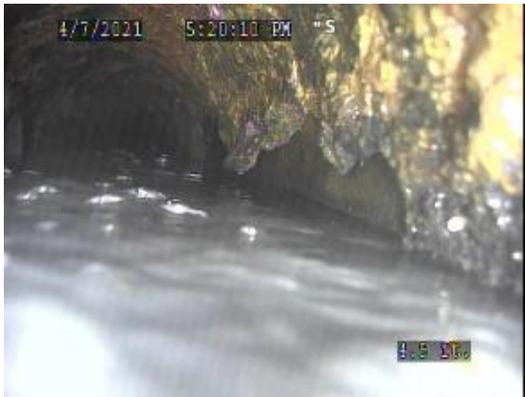
CO Q-8 to MH Q-9

According to Express Sewer, the entire reach of Keller Beach sanitary sewer was extremely corroded prior to cleaning. As shown in the post-cleaning images below, the upstream reach of pipe (MH Q-17 to MH Q-25) was generally descaled, while further downstream (MH Q-1 to MHQ-17) extensive turberculation and wall roughness remains.
