## 8.1 Berths 5-8 Condition Assessment Report

**POINT POTRERO MARINE TERMINAL  
BERTHS 5 TO 8 WHARF STRUCTURES CONDITION ASSESSMENT  
PORT OF RICHMOND**

**FOR MOFFATT & NICHOL**

**SITE VISIT DATE: MARCH 18 & 19, 2025**

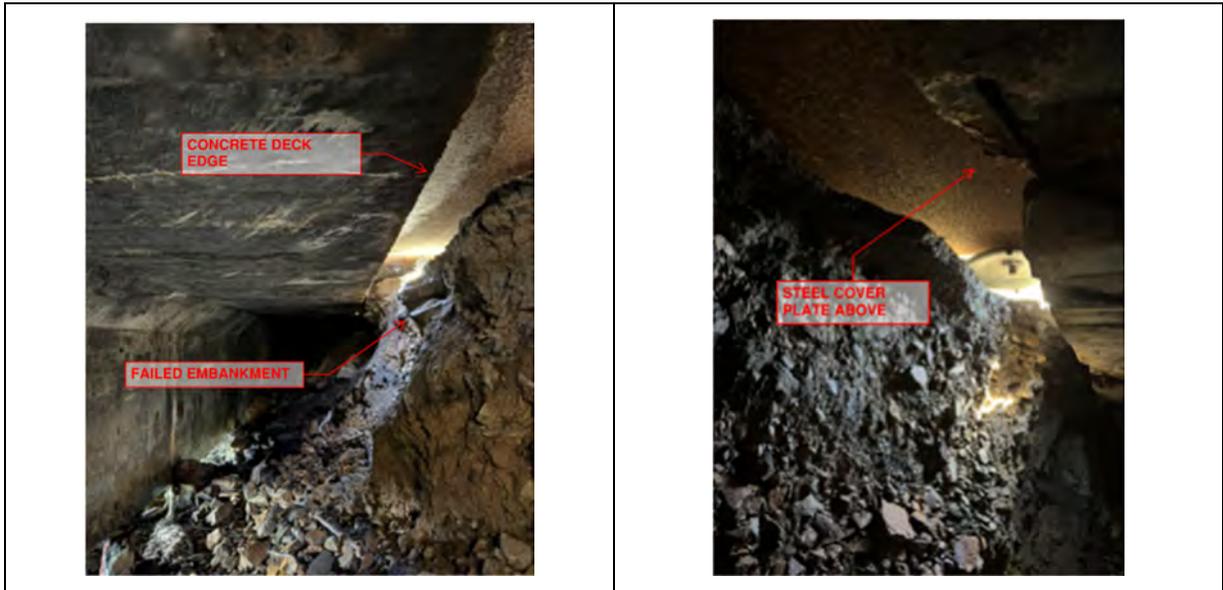
Since there is no seawall to protect the soil, the soil has eroded causing the pavement to lose support. The gap between the concrete deck edge and the soil grew bigger over time, requiring steel plates covering the gap as shown in the photograph below. Refer to Appendix I for embankment soil failure in the ENGEO report.

Photographs 5 and 6: Below deck, erosion and pavement failure, outer wharf and water to left, land to right

The pavement at the landside wharf edge has failed at several locations due to embankment erosion below. Refer to Appendix I for ENGEO's report for detailed clarification. This should be repaired by driving a steel sheet pile wall, backfilling, and repairing pavement.

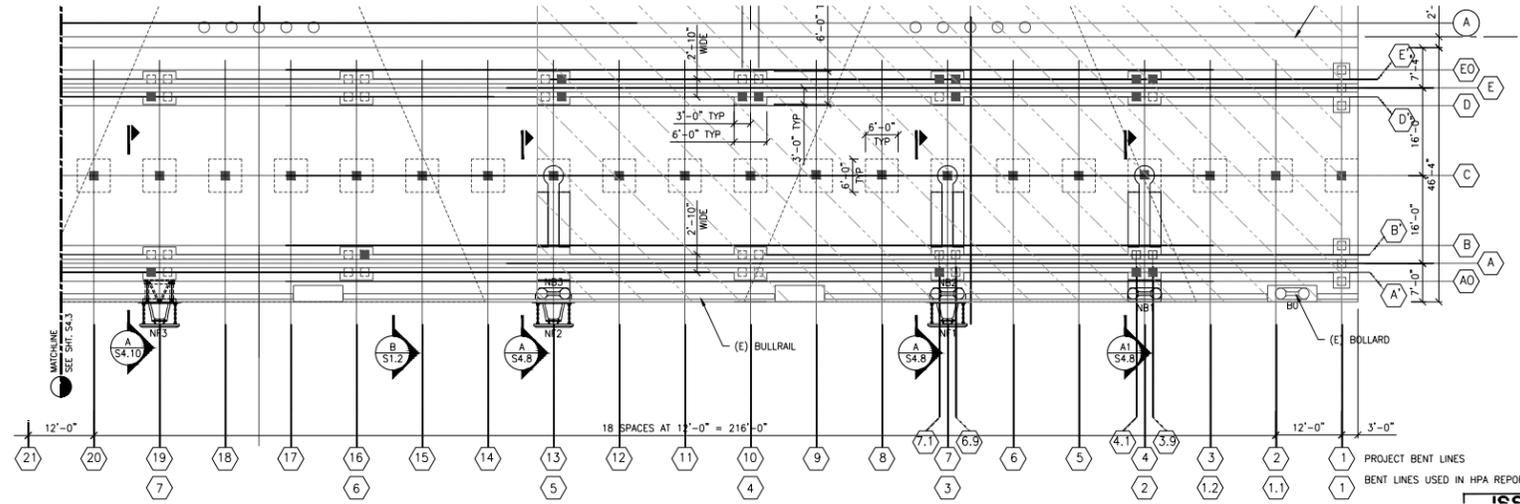
Spalled  
Concrete

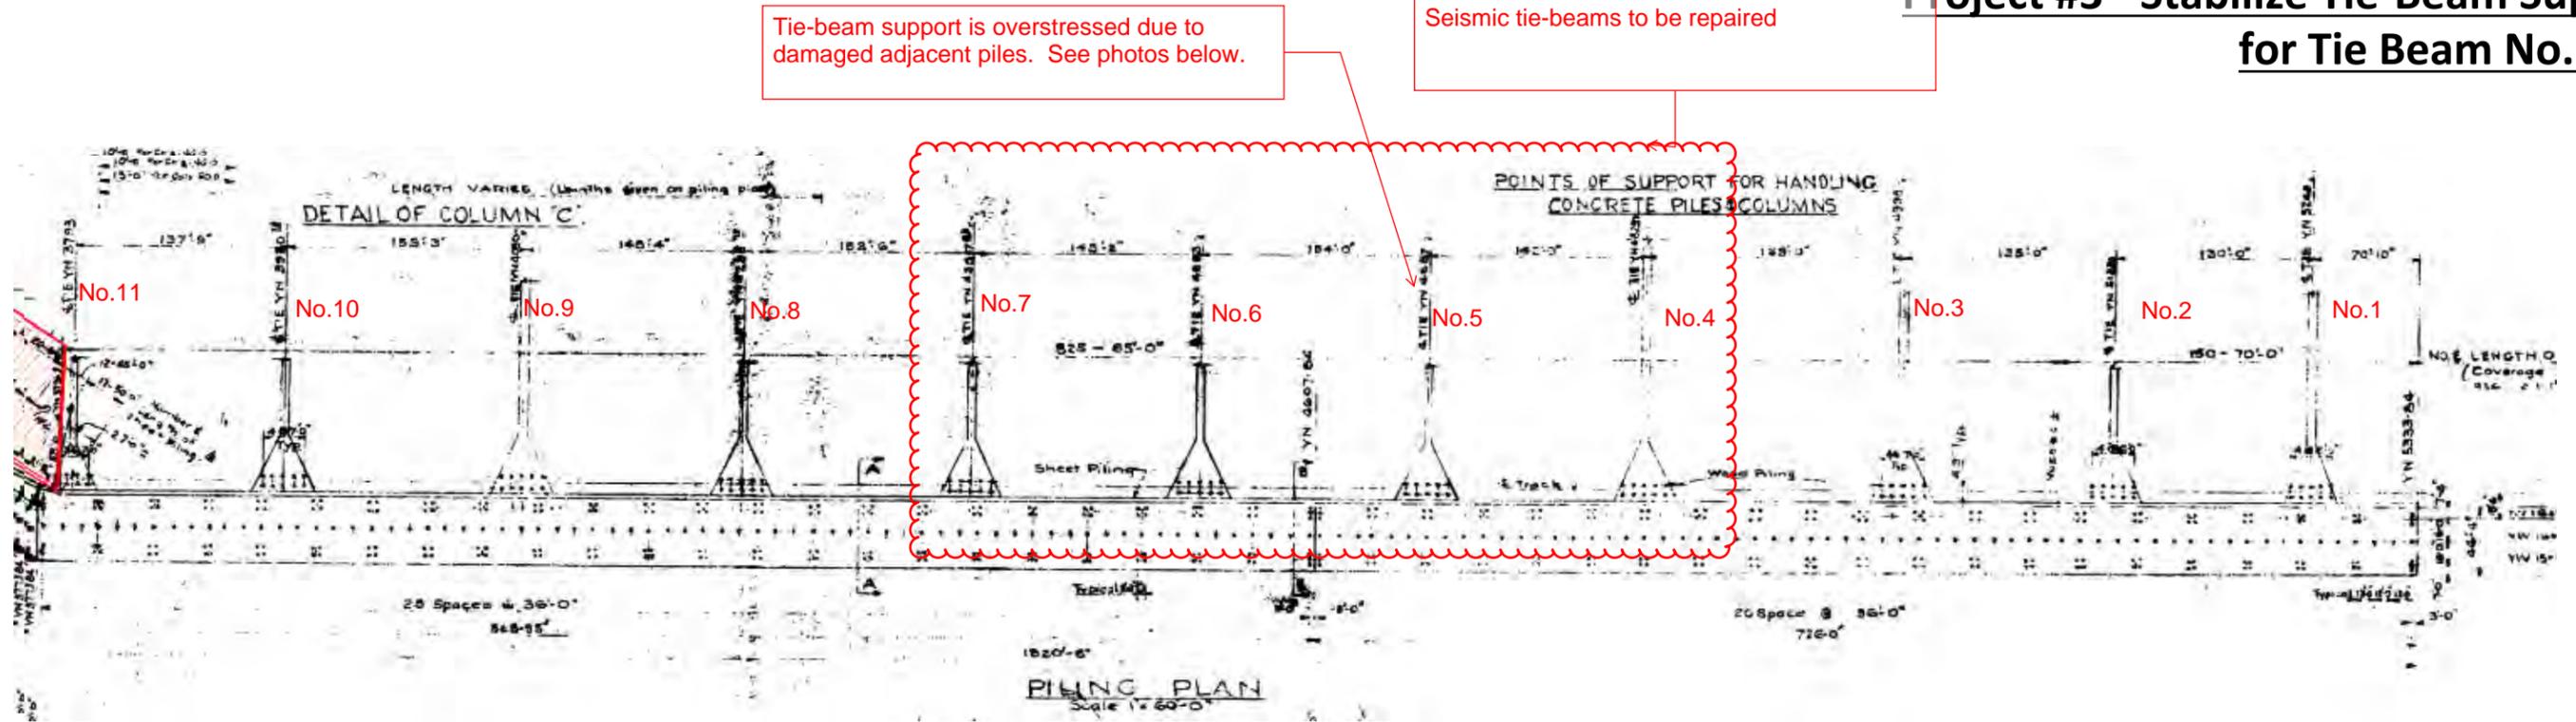
Missing piles

Pile overstressing

# Project #3 - Stabilize Tie-Beam Supports for Tie Beam No. 4 to 7

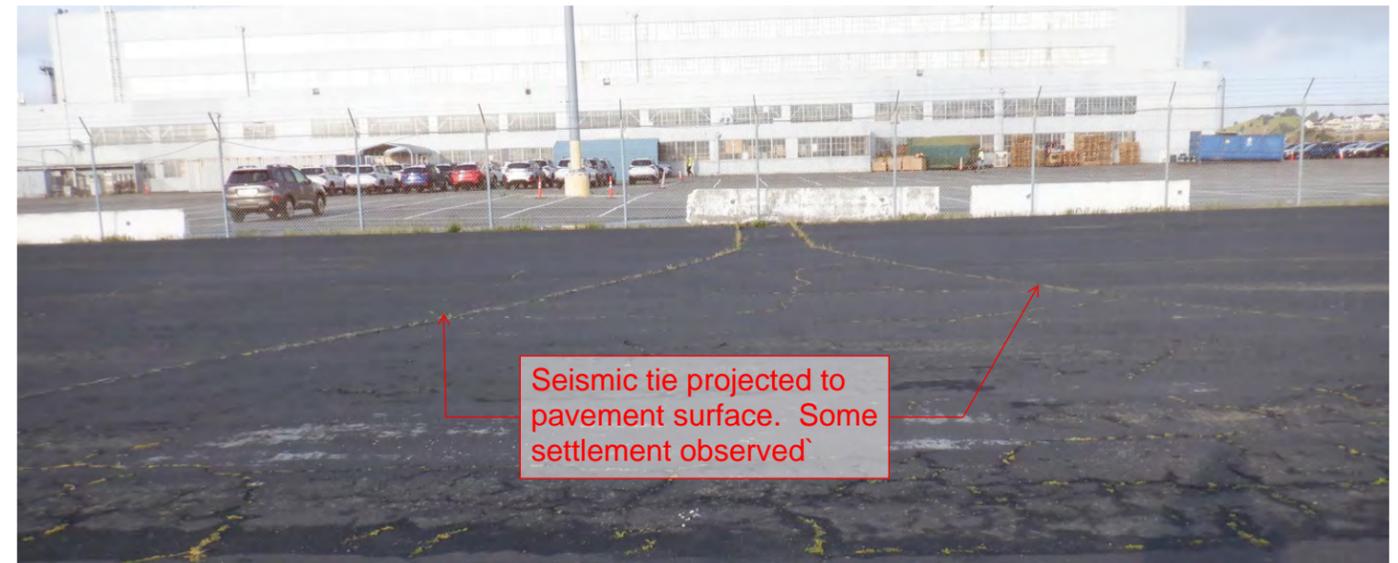
Seismic tie projected to pavement surface. Some settlement observed

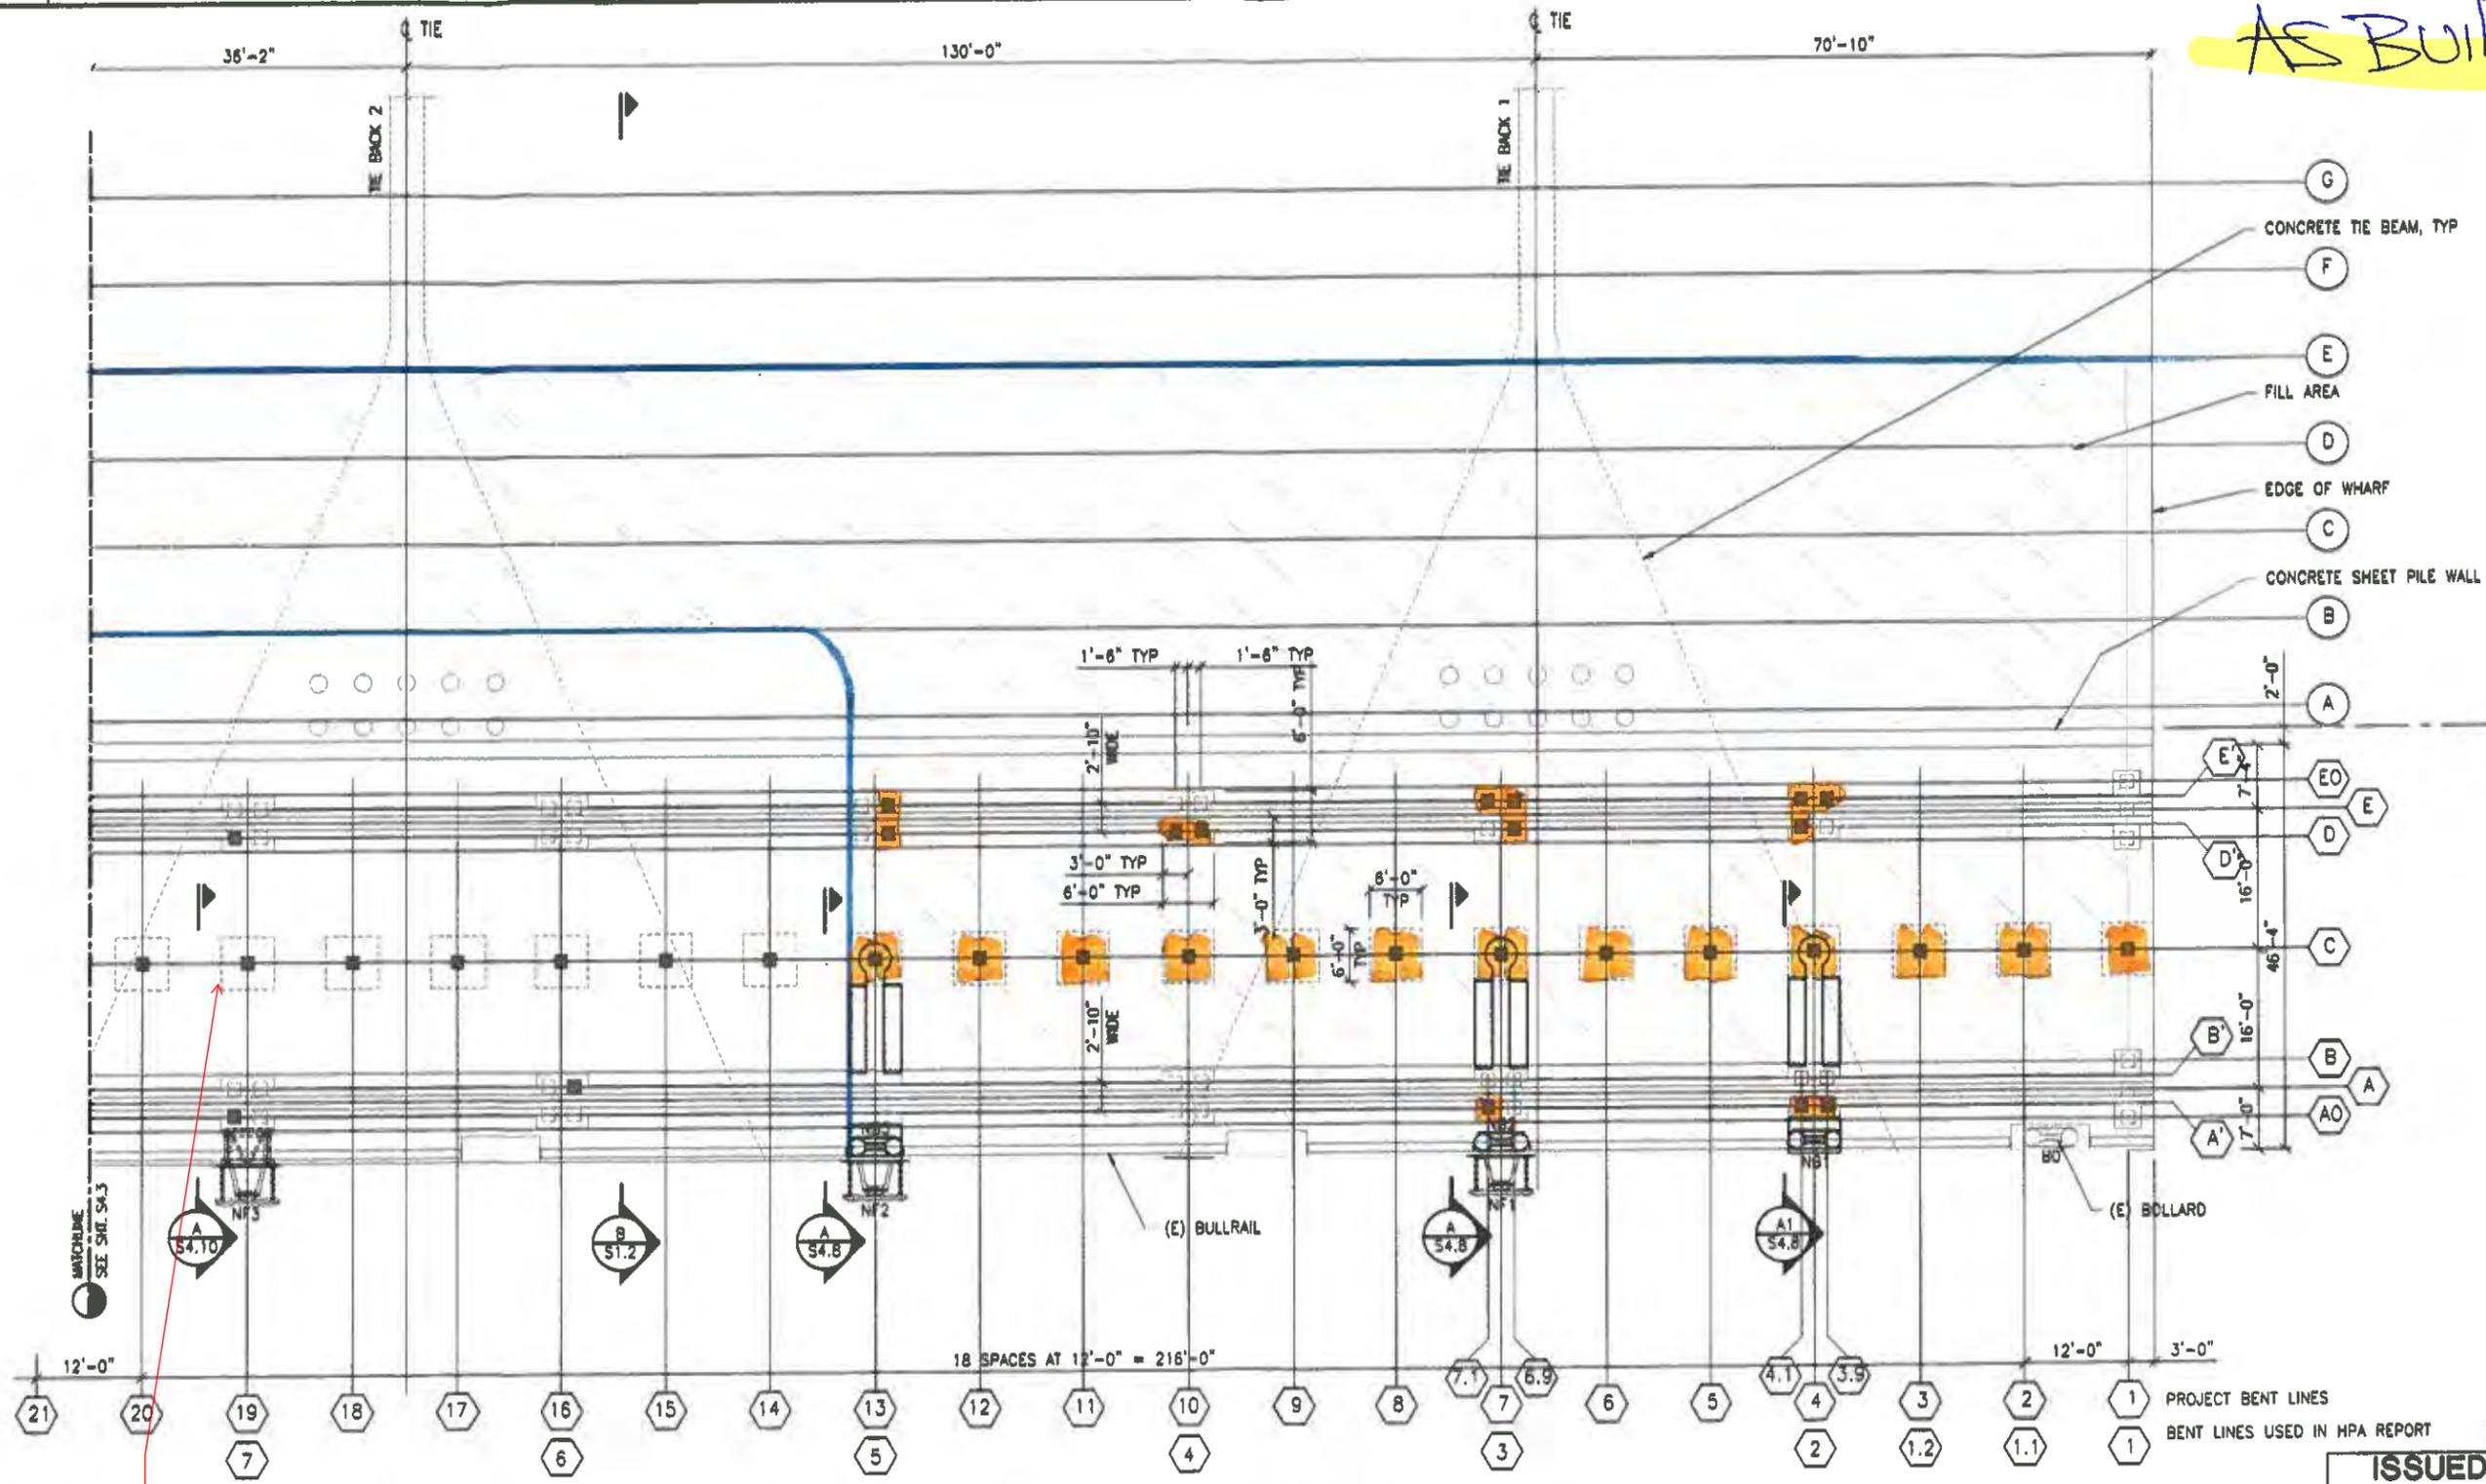
Damaged concrete piles = 8

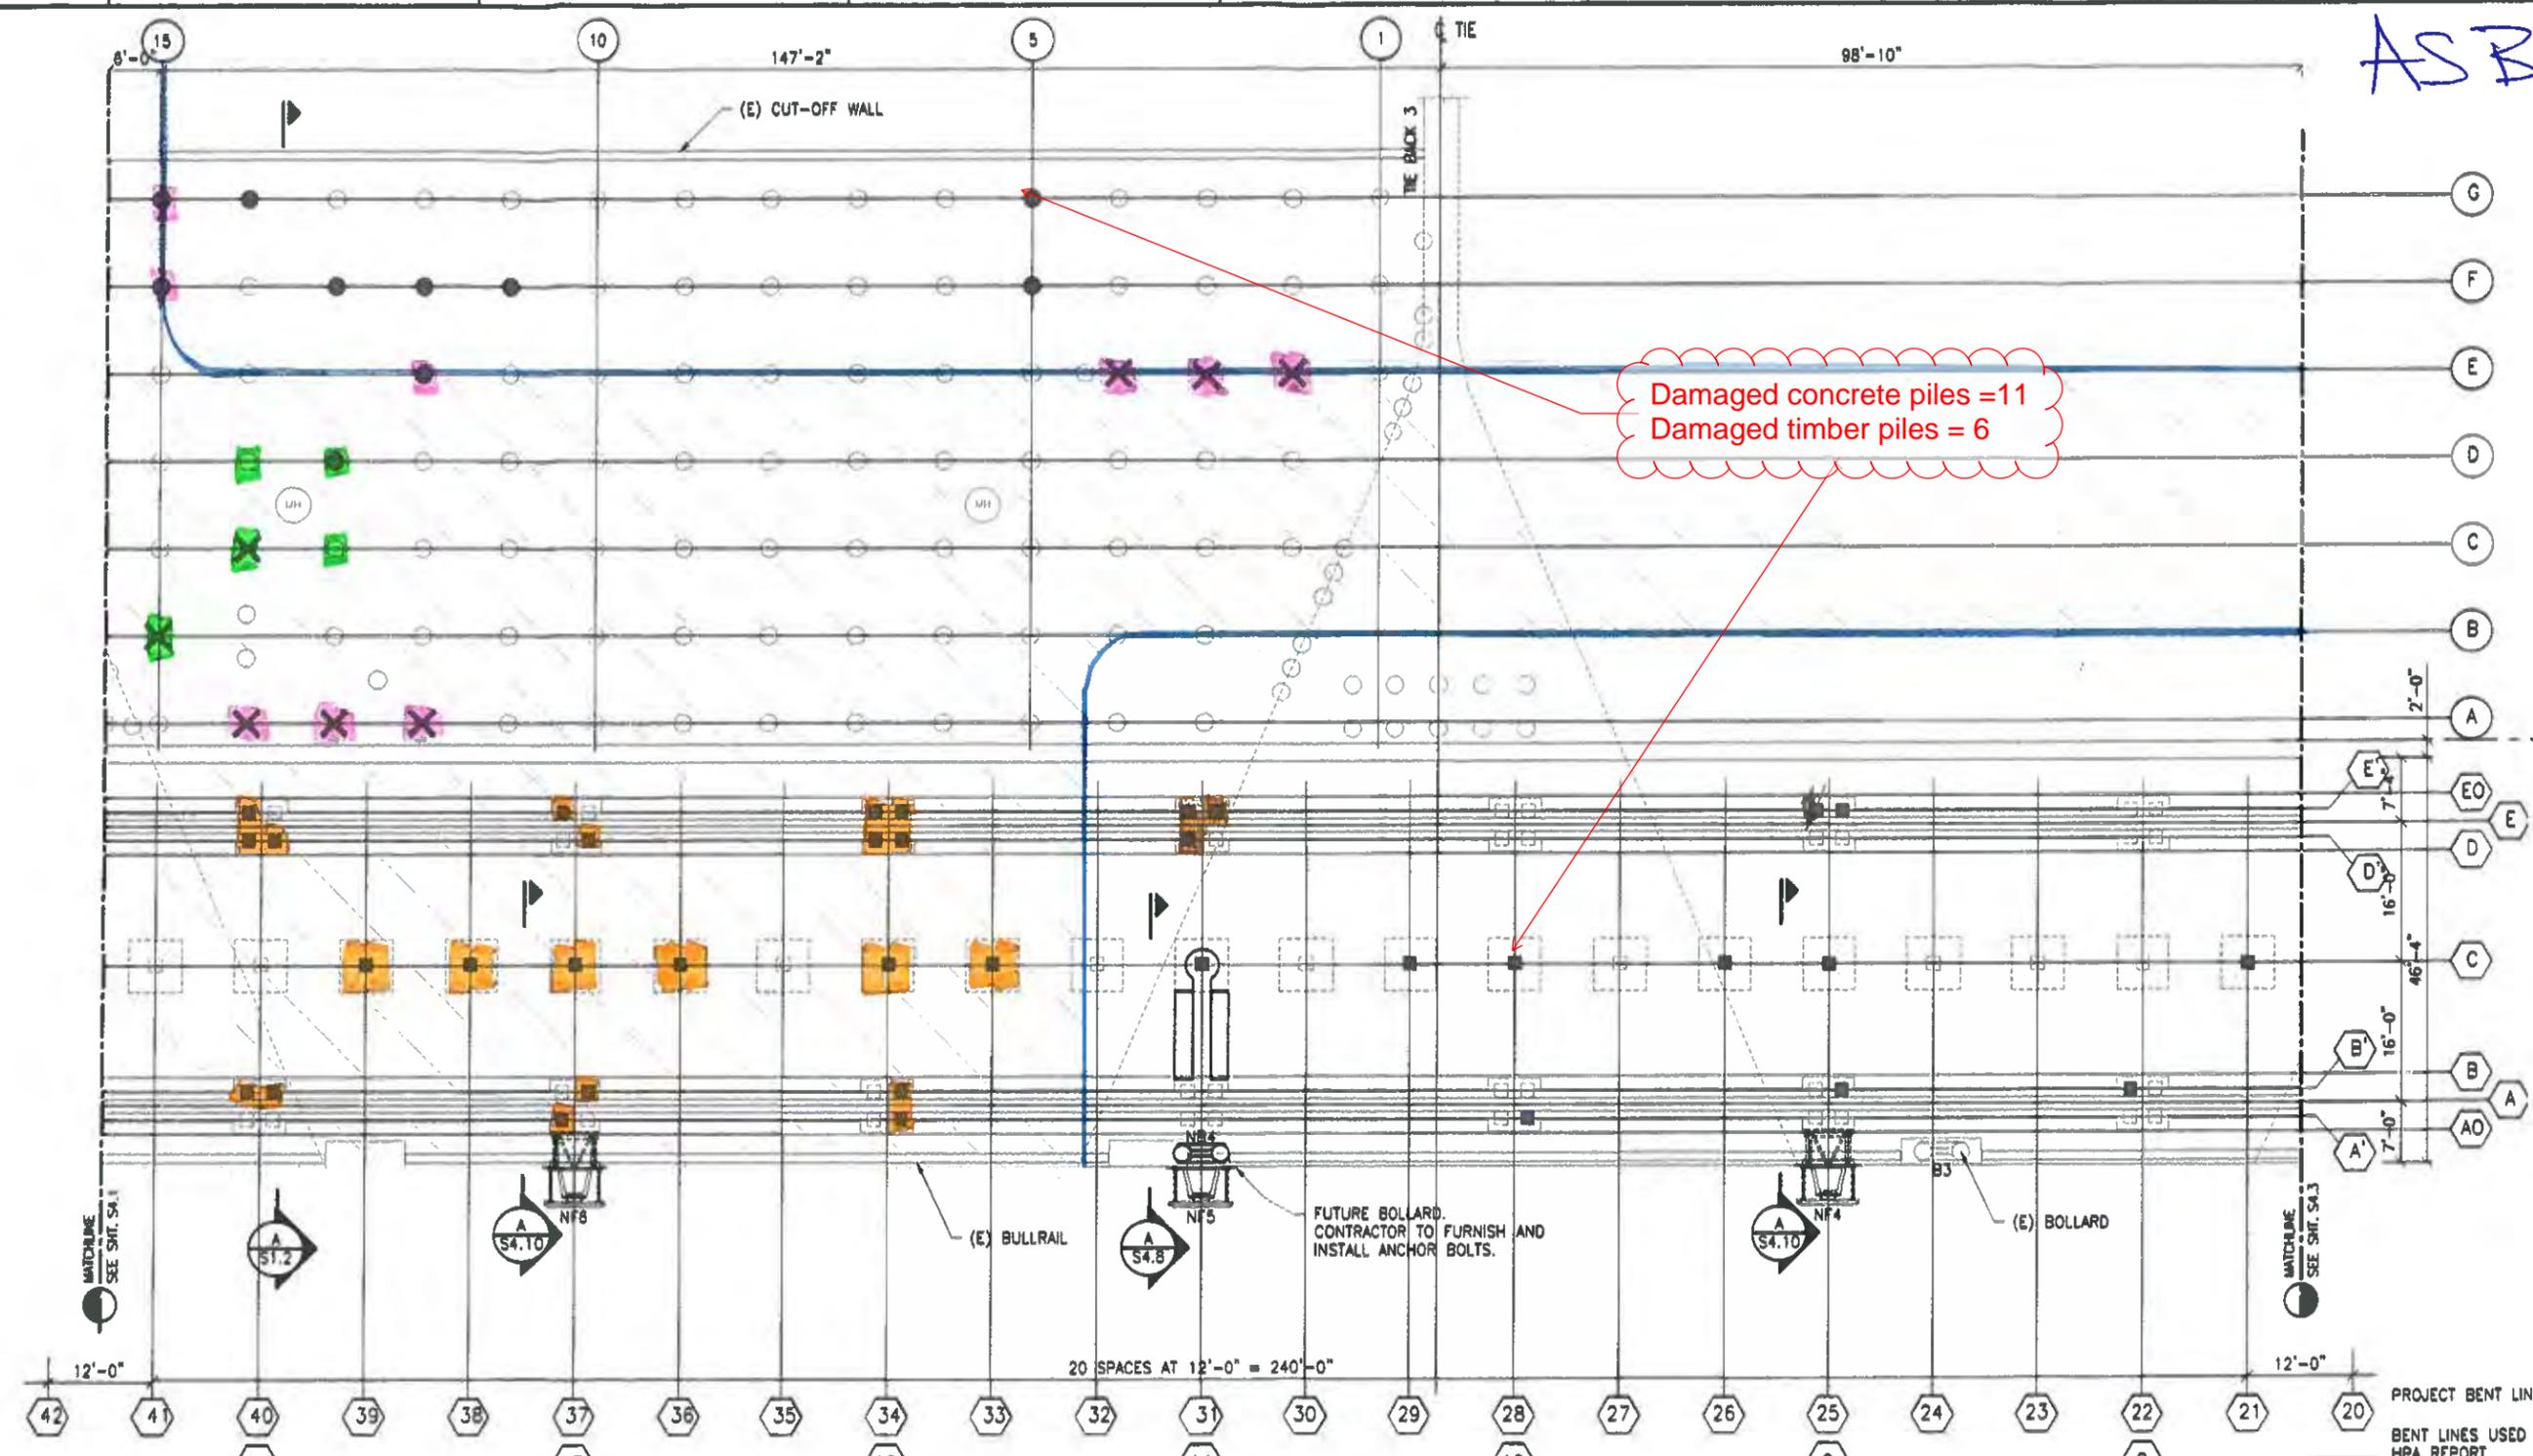
Damaged concrete piles = 11  
 Damaged timber piles = 6

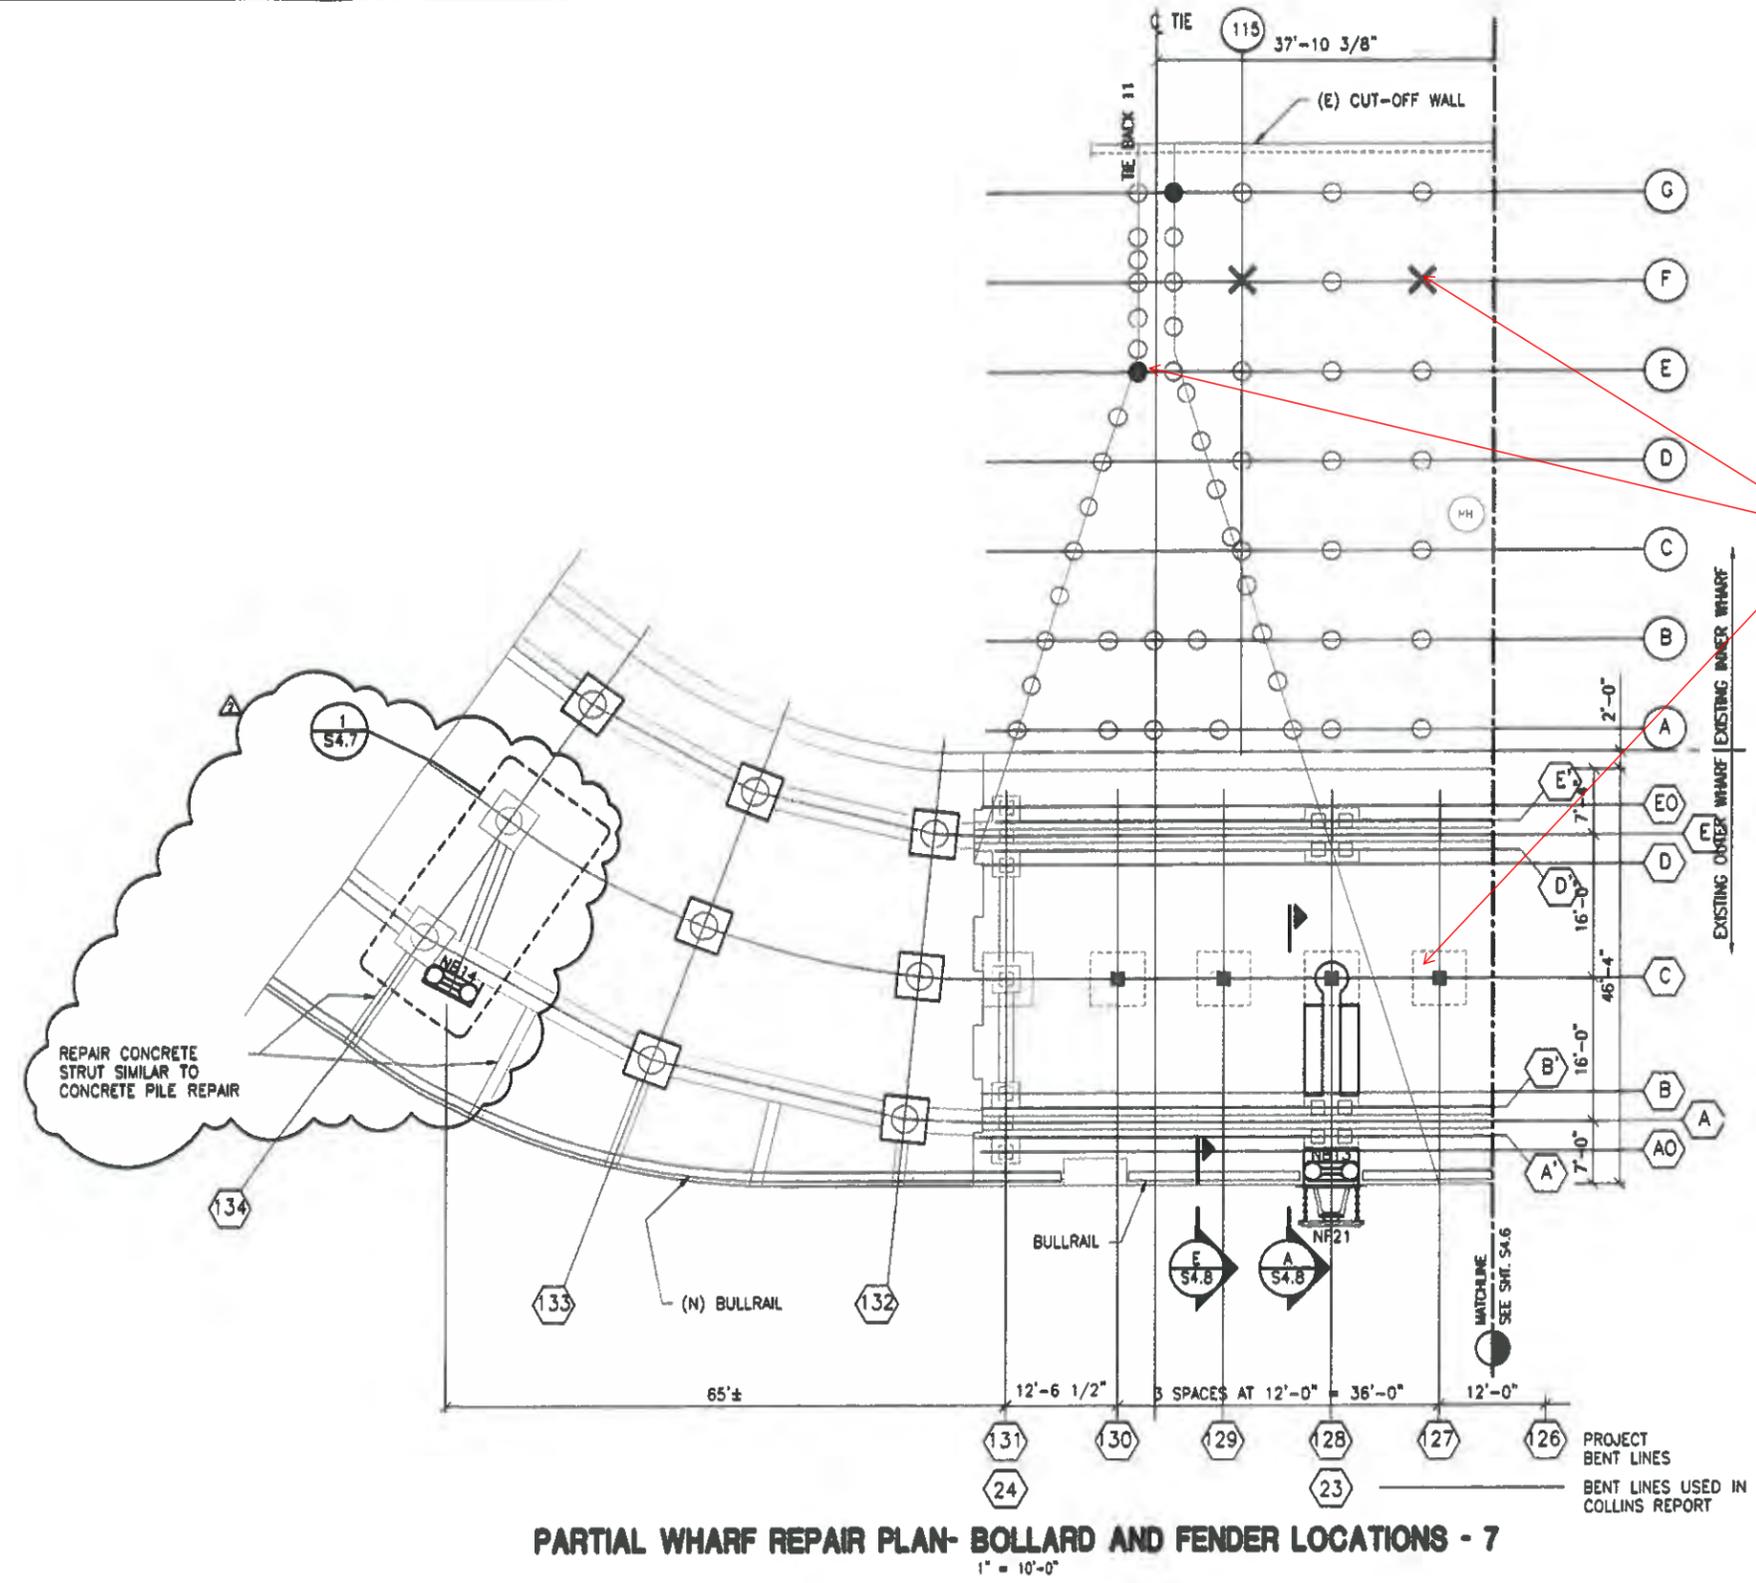
Damaged concrete piles = 4  
 Damaged timber piles = 2  
 Missing timber piles = 2

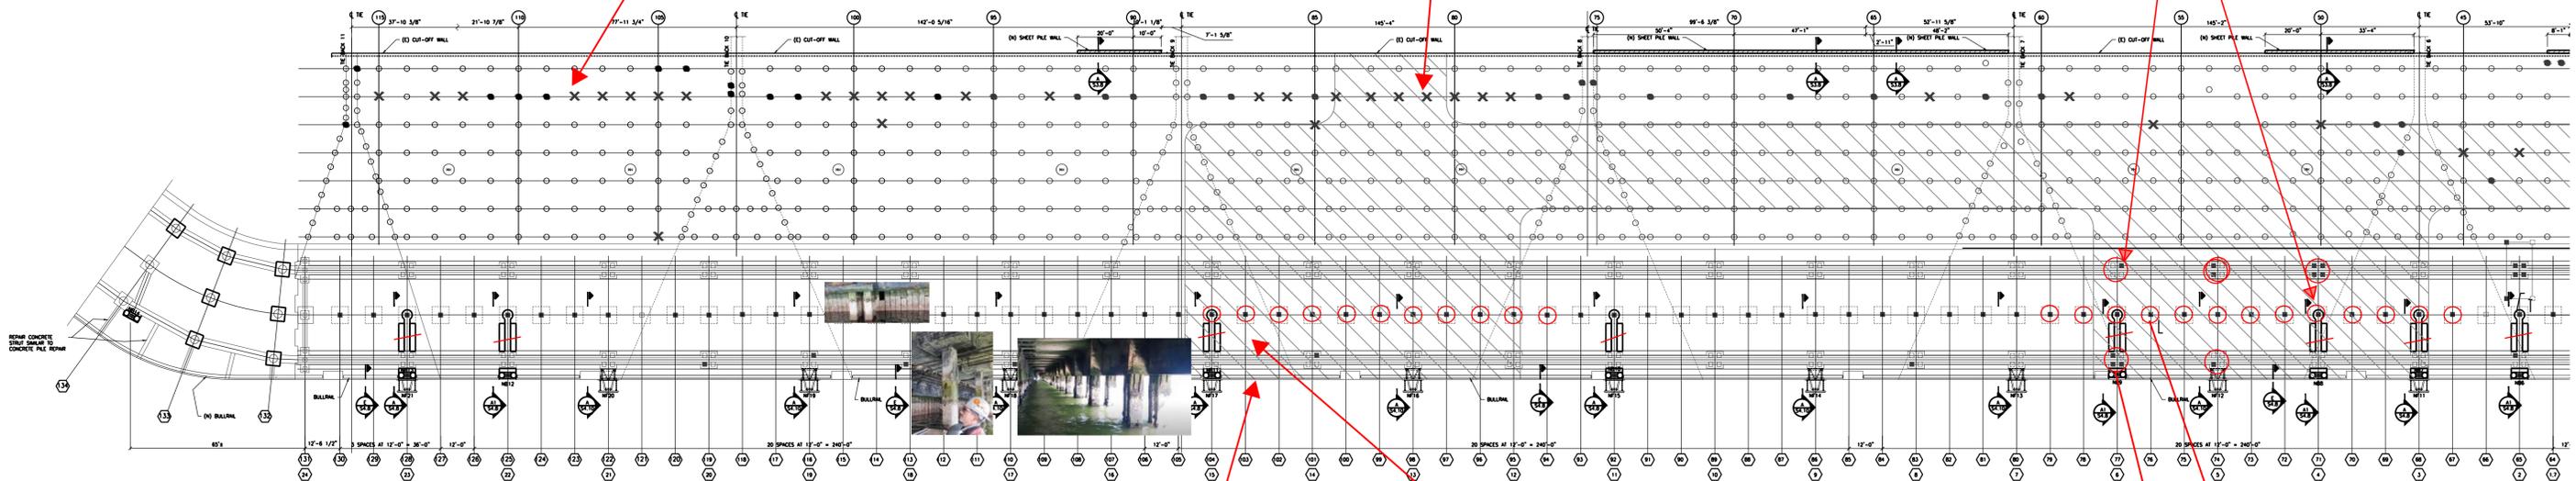
Delamination and Spalling Concrete near Wharf Face
