Subject: First Quarter 2013 Installation Restoration Site 1 Landfill Post-Closure Monitoring Report,
Former Naval Fuel Depot Point Molate, Richmond, California

1st QUARTER 2013 LANDFILL MONITORING REPORT IR SITE 1, FORMER NAVAL FUEL DEPOT POINT MOLATE, RICHMOND, CALIFORNIA

Project Number 0001.001.026

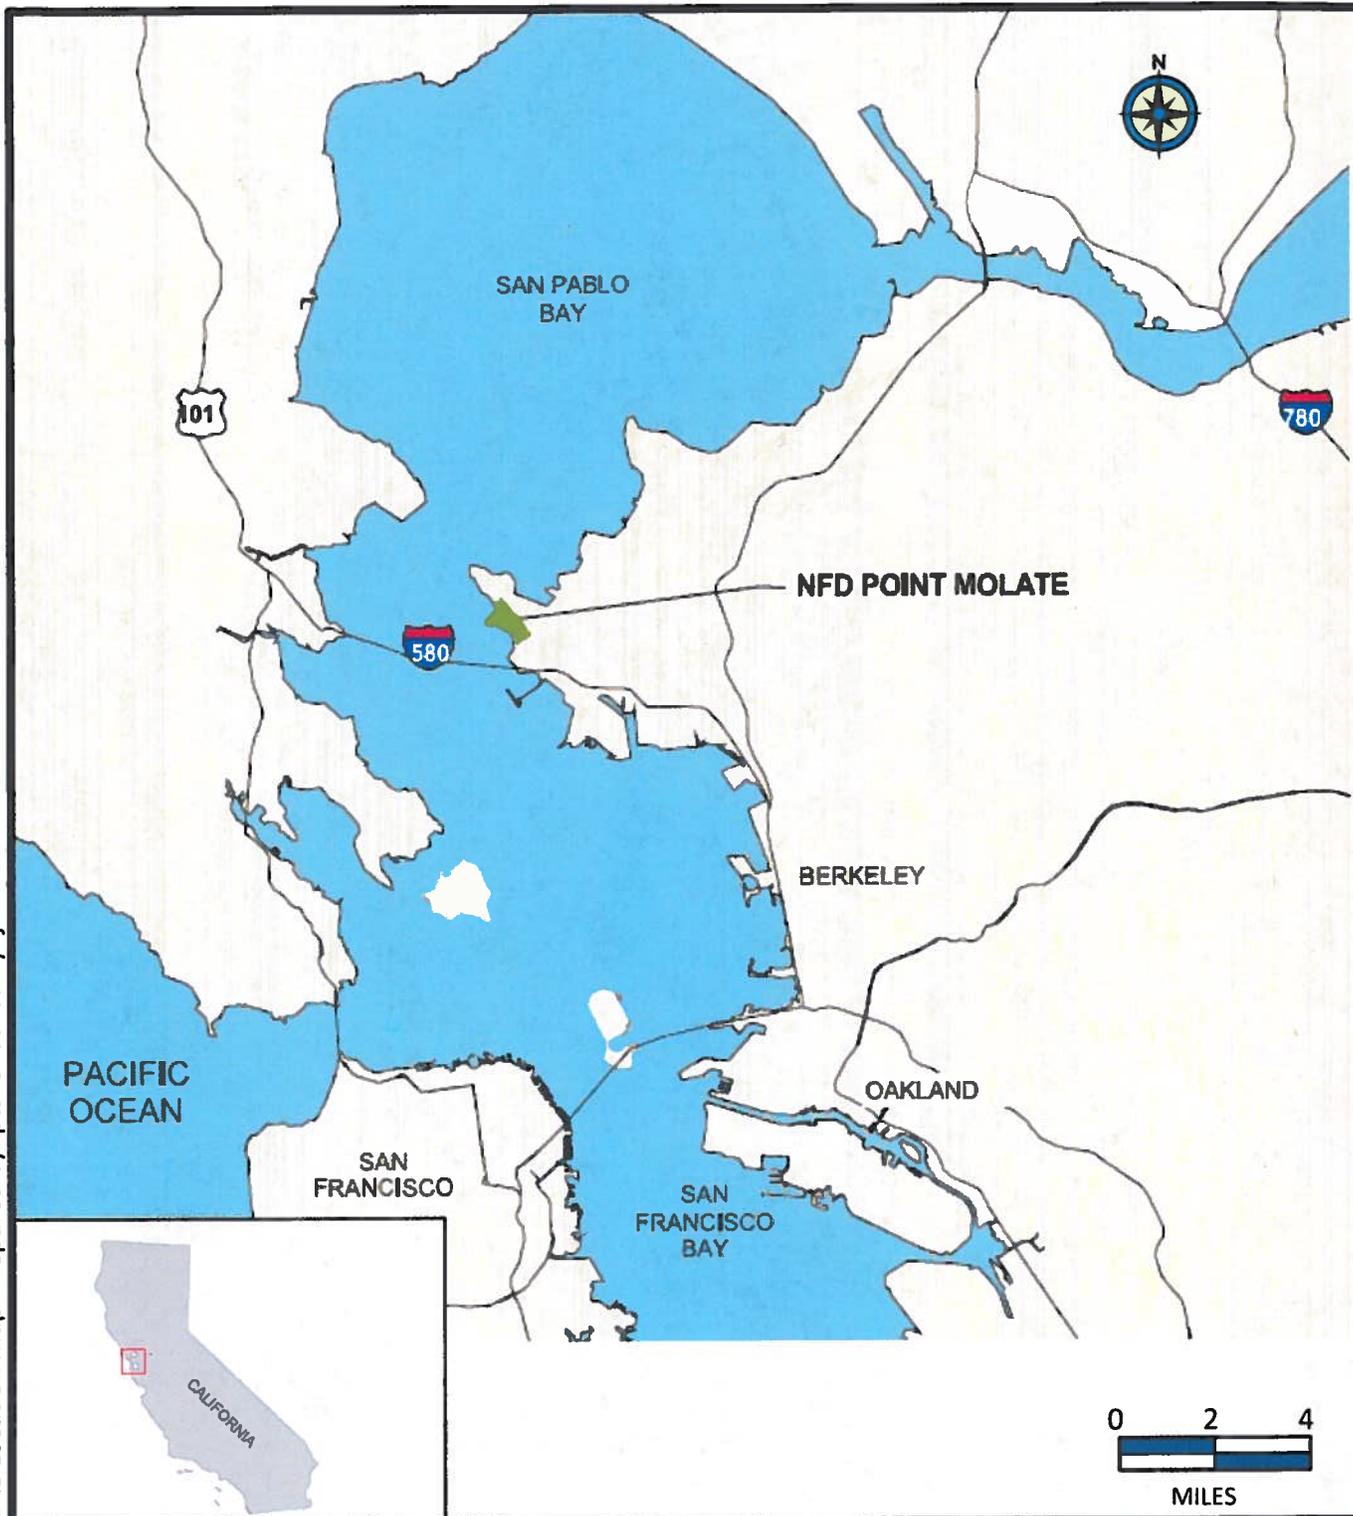
FIGURE 1

SAFETY FIRST	CLIENT: Upstream Point Molate LLC	Site Location Map

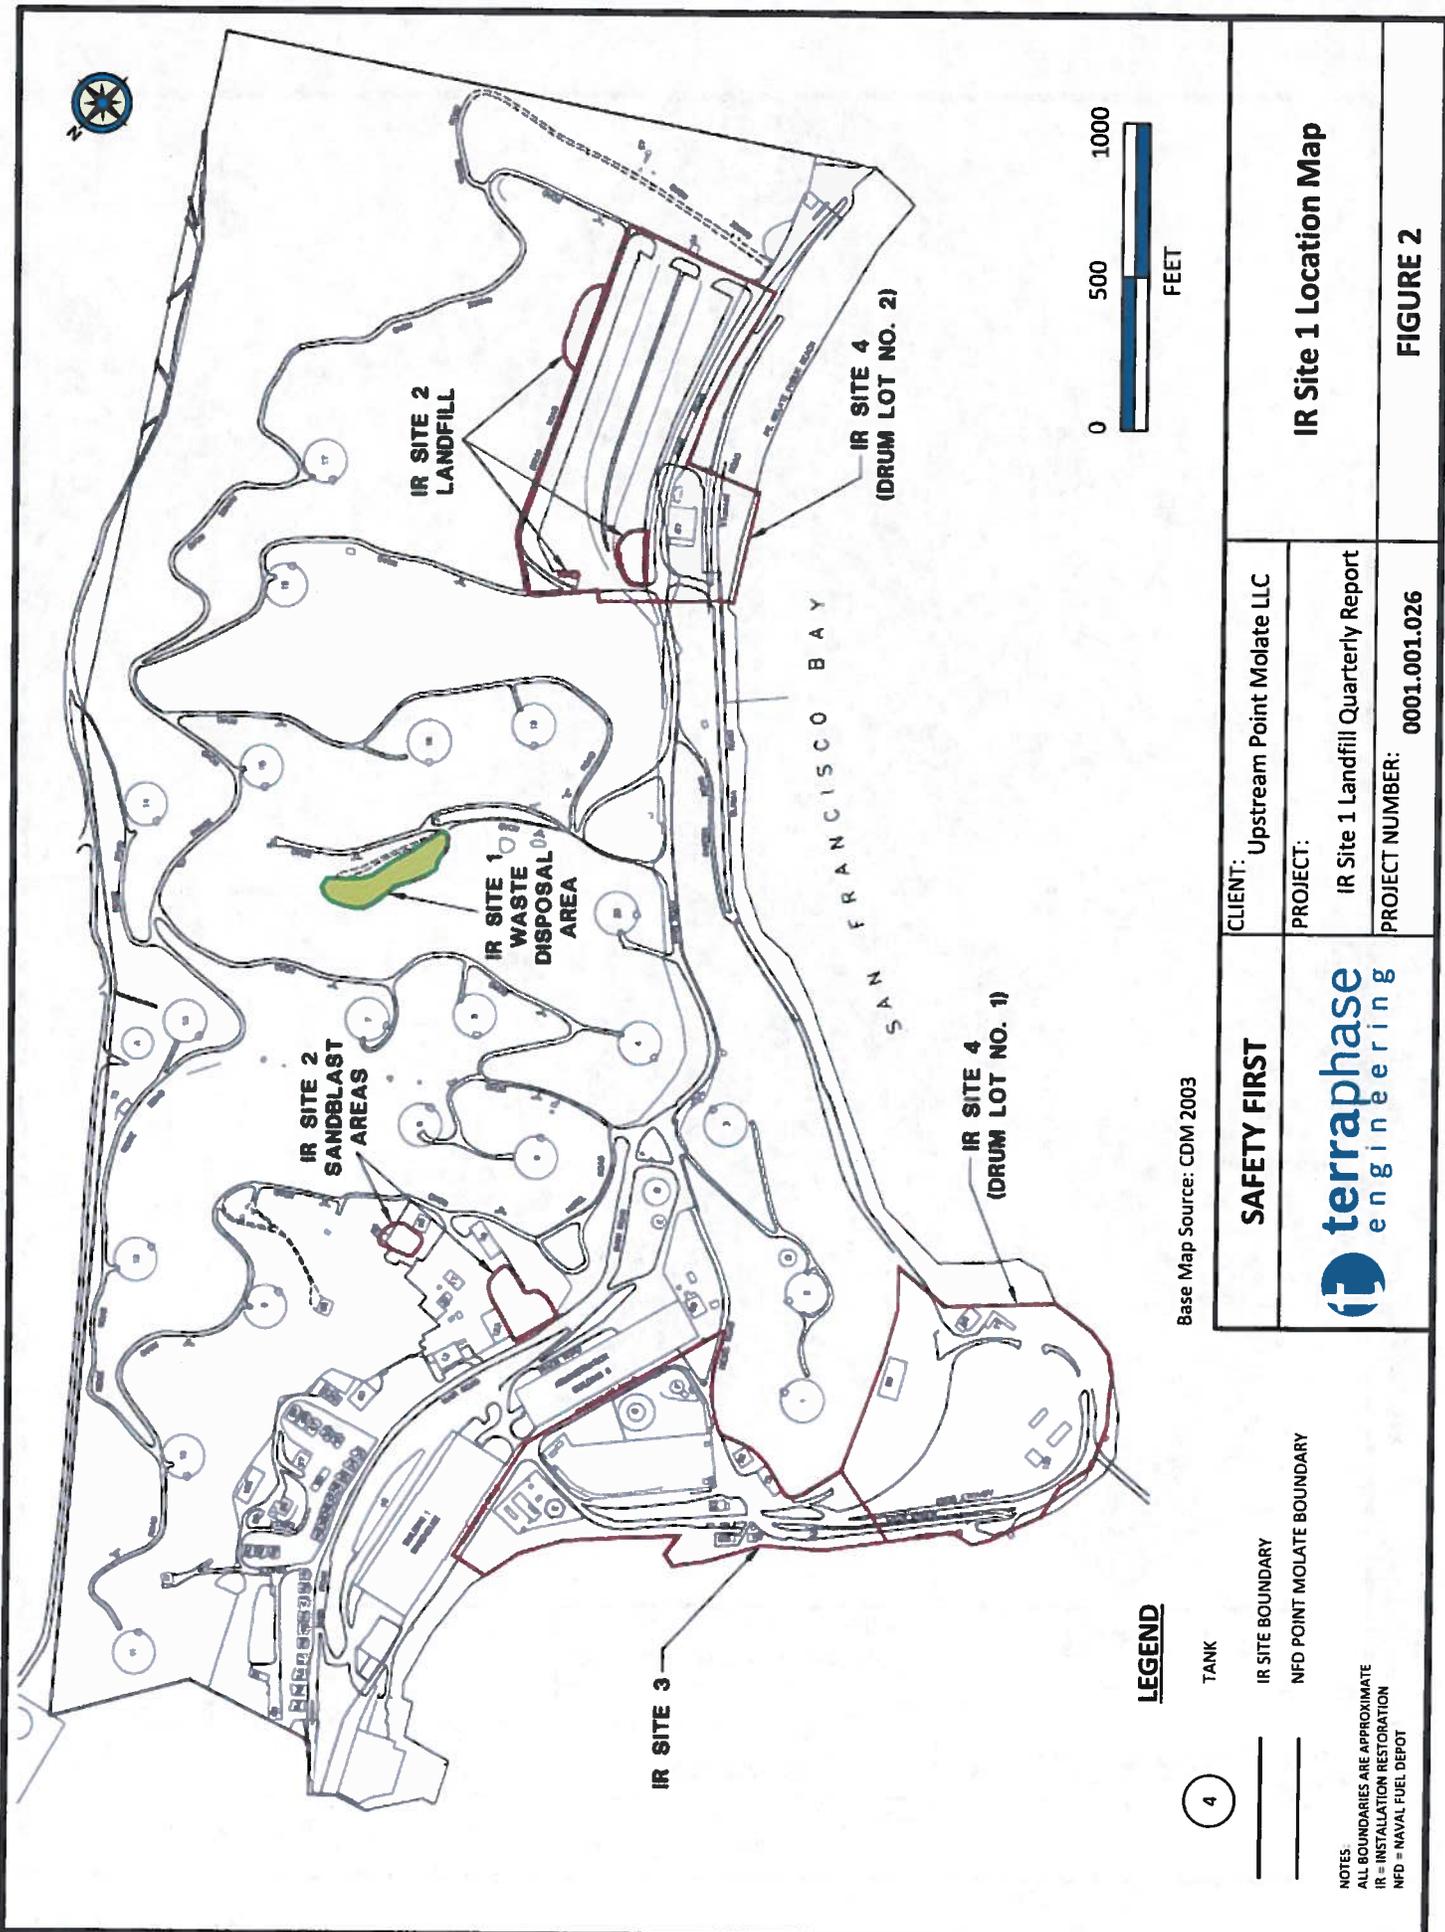
FIGURE 2

The IR Site 1 landfill, as shown in Figure 2, is located approximately 1,000 feet east of San Francisco Bay, near the center of the former NFD Point Molate. From approximately 1957 until 1979, IR Site 1 was primarily used for disposal of construction and landscaping debris. The debris was deposited over a one-acre area. In 1998, an investigation was conducted to determine the general nature and extent of the waste in the landfill. The estimated volume of fill at IR Site 1 was 20,000 cubic yards (TtEMI 2001a). The soil cover for IR Site 1 was designed in 2001 and constructed in 2002. The soil cover is three feet thick, has drainage controls and a monitoring system, and was hydroseeded with an annual native grass for erosion protection. The area of the IR Site 1 soil cover is shown on Figure 3.

IR Site 1 Location Map

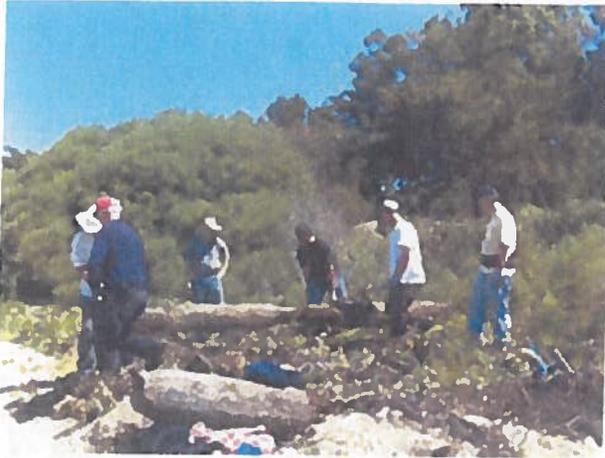
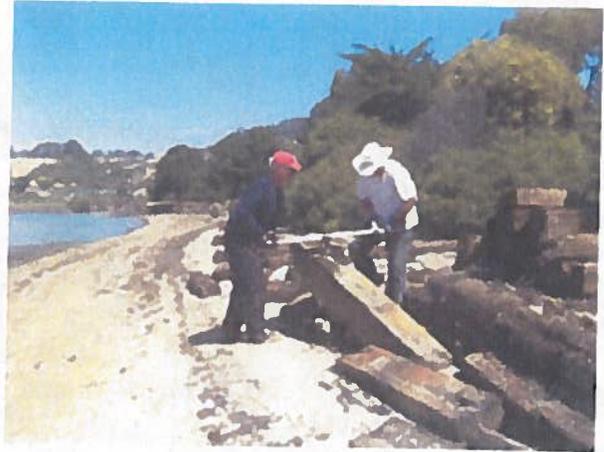
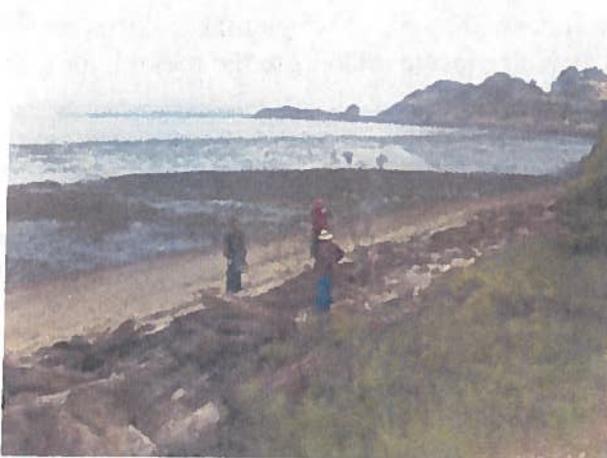
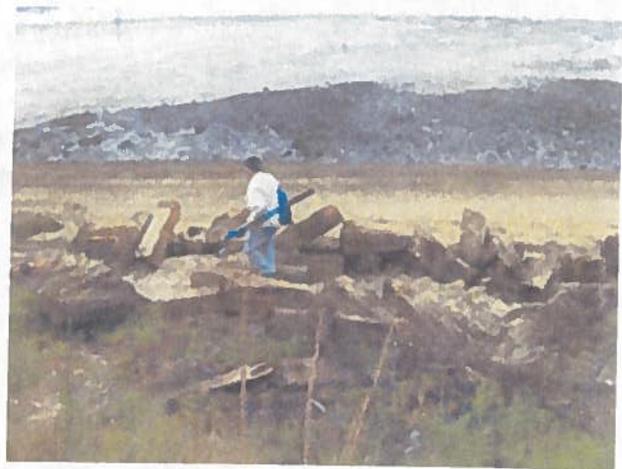
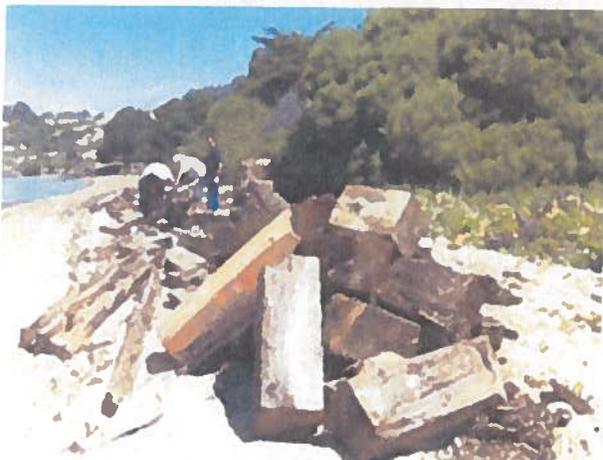
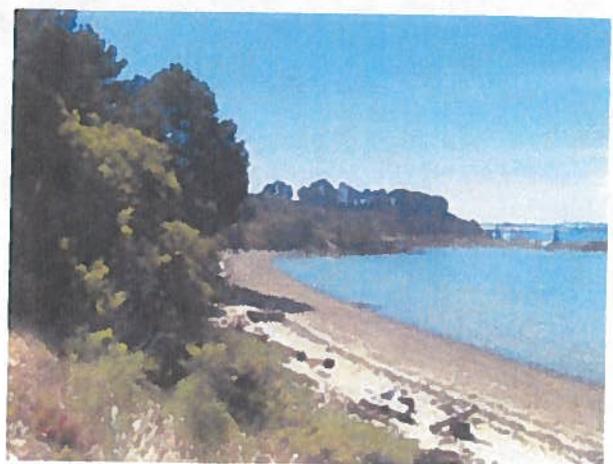
Pt Molate Beach Marine Debris Clean-Up

- Since March Baykeeper and local volunteers have mobilized hundreds of contaminated pilings and other debris for removal.
- The large pier section along the beach has been sectioned for removal, along with rusted pipe, tires, and other debris.
- Next week, the week of June 17, removal operations will begin, at which time a skip steer (Bobcat) will be used to remove large material from the beach and re-locate it closer to the parking lot for subsequent removal via debris bins.
- The City has generously offered to assist in disposal of non-creosote contaminated material. All contaminated material shall be disposed of at a landfill in Pittsburg authorized to receive treated wood waste.
- In total, Baykeeper hopes to remove approximately 100 tons of material from the Pt. Molate Beach Park and surrounding shoreline by August of this year.
