Subject: Second Quarter 2013 Self-Monitoring Report for the Packaged Groundwater Treatment Plant, Former Naval Fuel Depot Point Molate, Western Drive, Richmond, California (CIWQS 657165) Order No. R2-2012-0012, NPDES No. CAG912002

PGWTP 2013 Second Quarter Operations

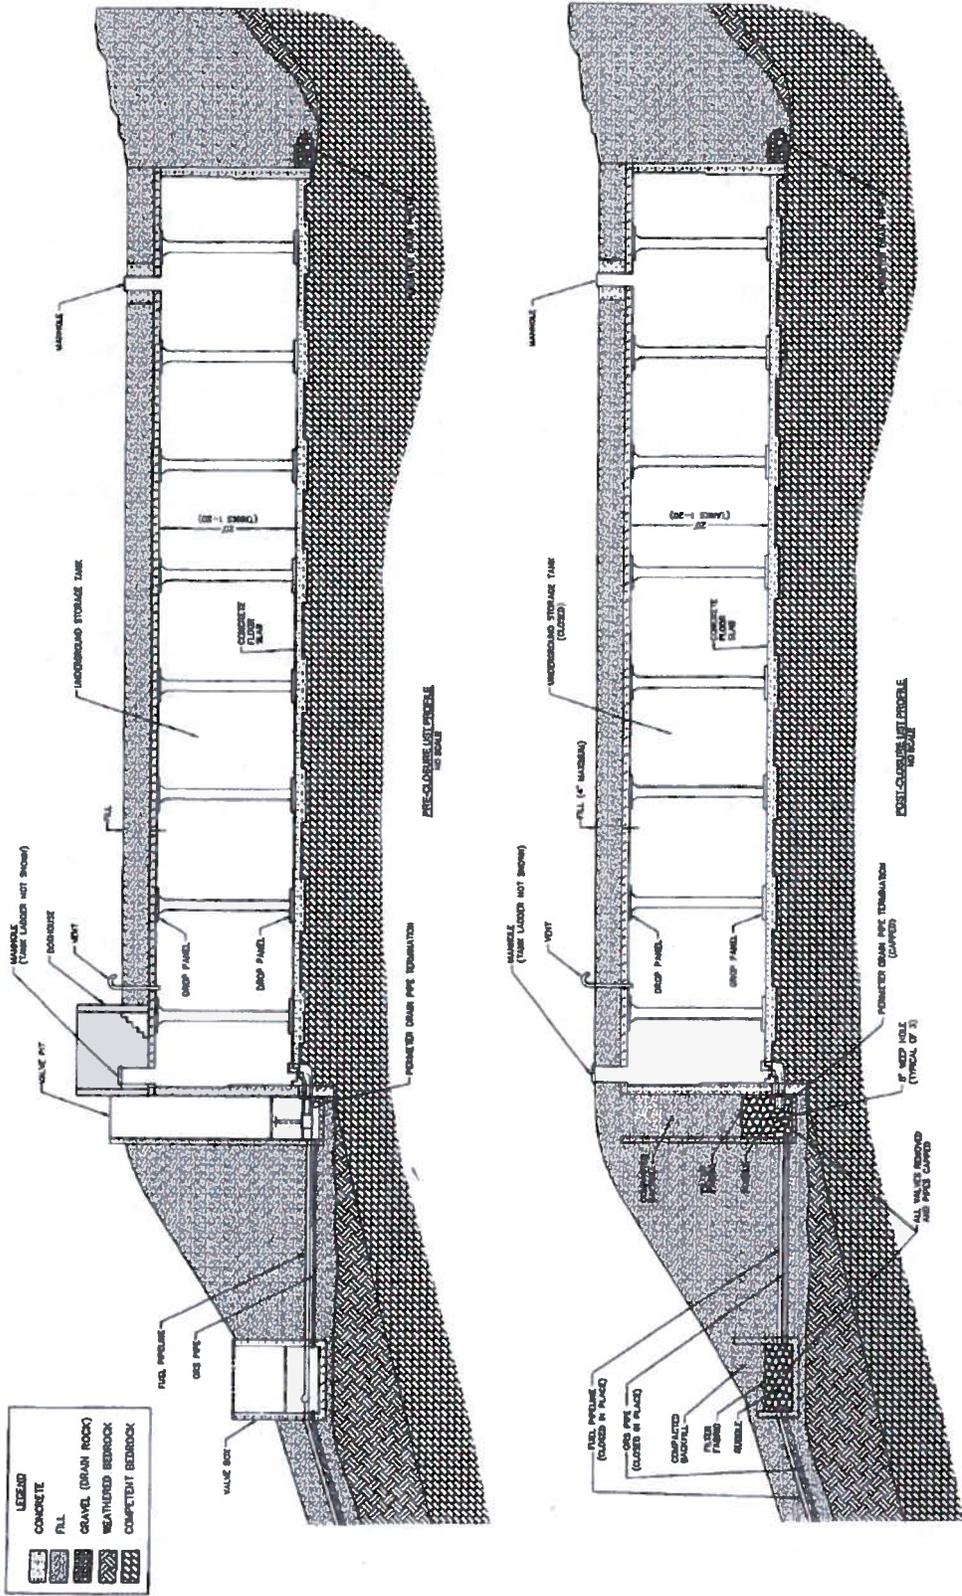
SAFETY FIRST 	CLIENT: Upstream Point Molate, LLC	UST Cross Section	
	PROJECT: UST Monitoring Report		
	PROJECT NUMBER: 0001.001.020	FIGURE 3

Each UST was constructed with a perimeter drain surrounding the tank bottom. Original design drawings indicate that each drain consisted of open joint tiles placed in a gravel bed. Each drain was laid on a slope to fall approximately 12 inches from the upper (uphill side) UST perimeter to the lower (downhill side) perimeter. Water collected by these drains was to the oil recovery system (ORS; TtEMI, 2002). The purpose of the perimeter drains was to prevent infiltrating surface water from accumulating in the backfill outside of the UST walls. Figure 3 is a typical cross section of a UST at former NFD Point Molate.
