CITY OF RICHMOND  
**Pt. Molate Community Advisory Committee**  
Monday, May 8, 2017 6:30 - 9:00 pm  
Multi-Purpose Room, 440 Civic Center Plaza

***AGENDA***

environmental closure from the RWQCB. Regardless of the closure status of the USTs with the RWQCB, they require on-going maintenance and monitoring to reduce the chances that they will become a physical hazard. This report describes the monitoring and maintenance for USTs 1 through 20.

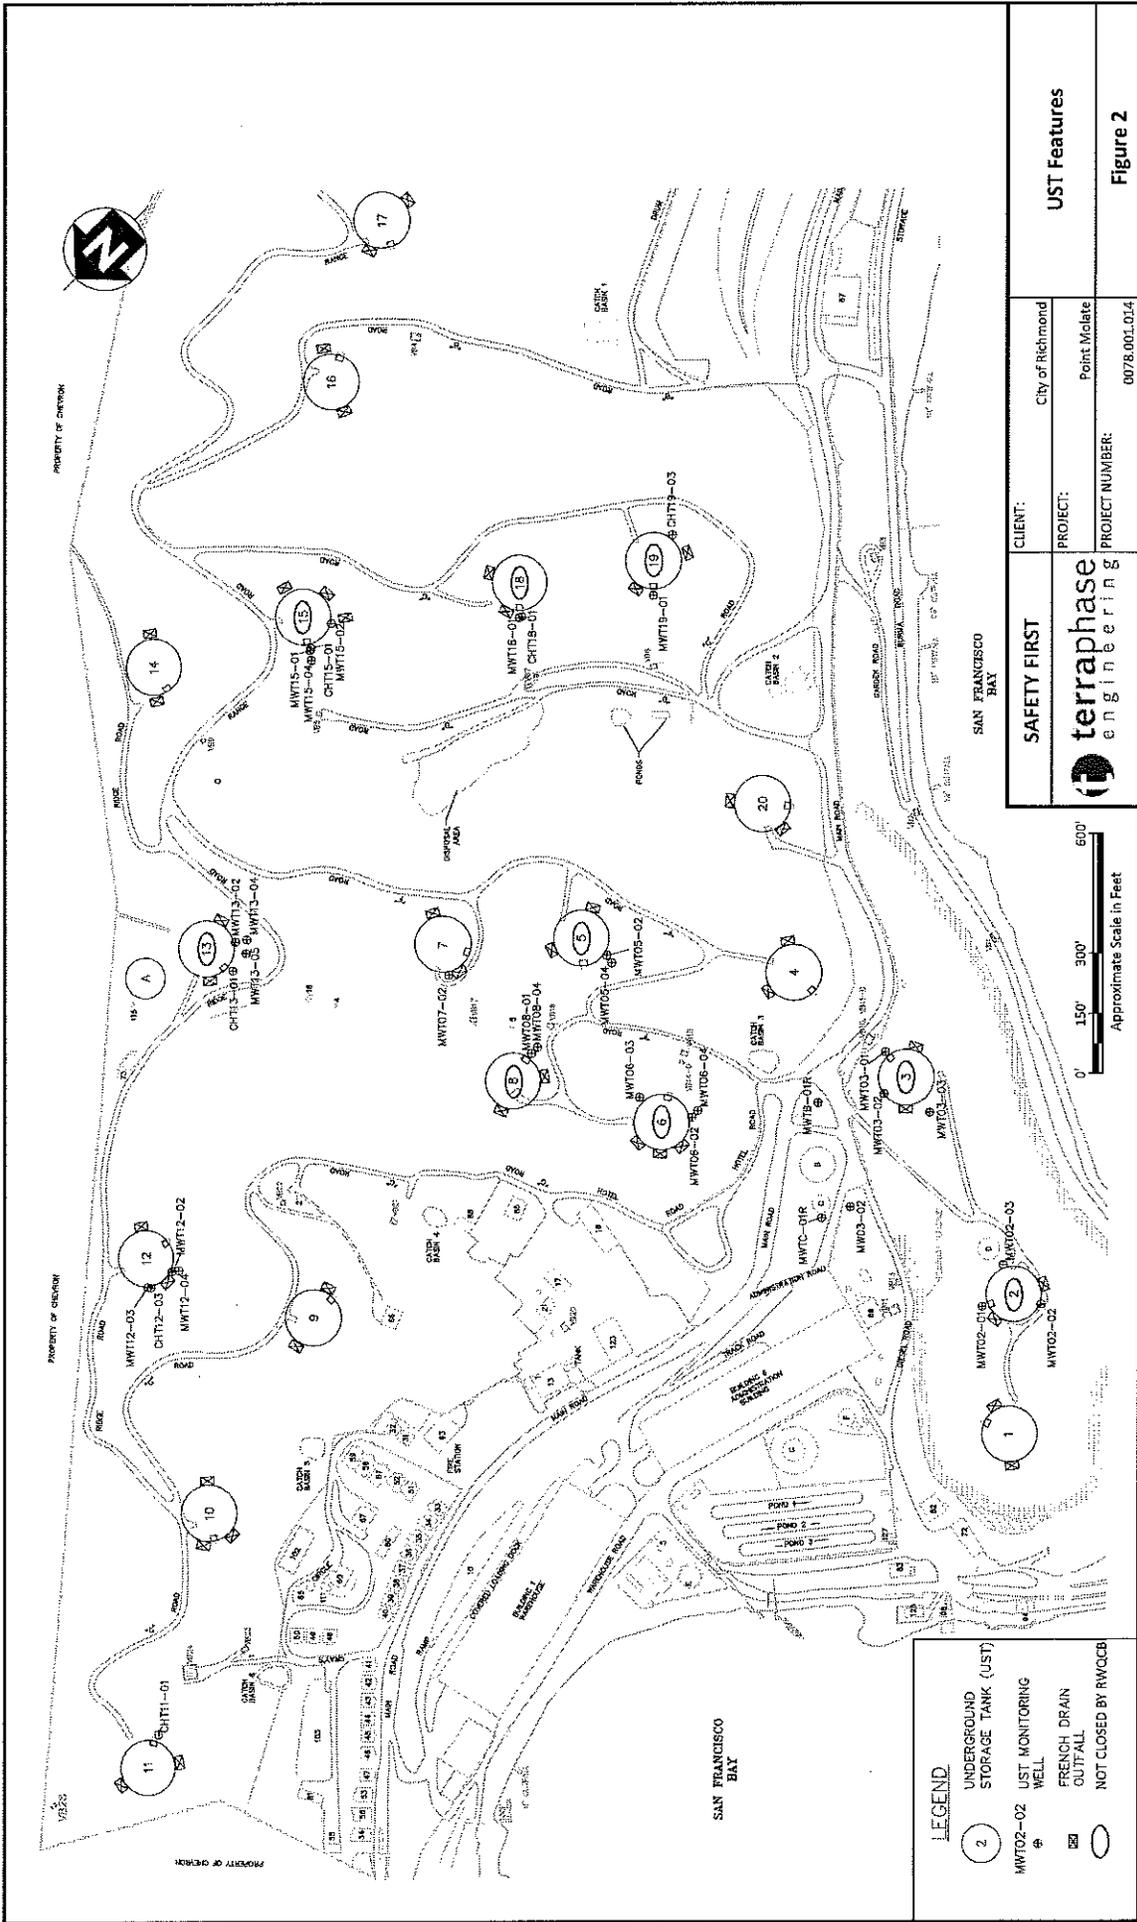
Figure 2

- 2 UNDERGROUND STORAGE TANK (UST)
- MWTO2-02 UST MONITORING WELL
- ☐ FRENCH DRAIN
- OUTFALL
- NOT CLOSED BY RWQCB

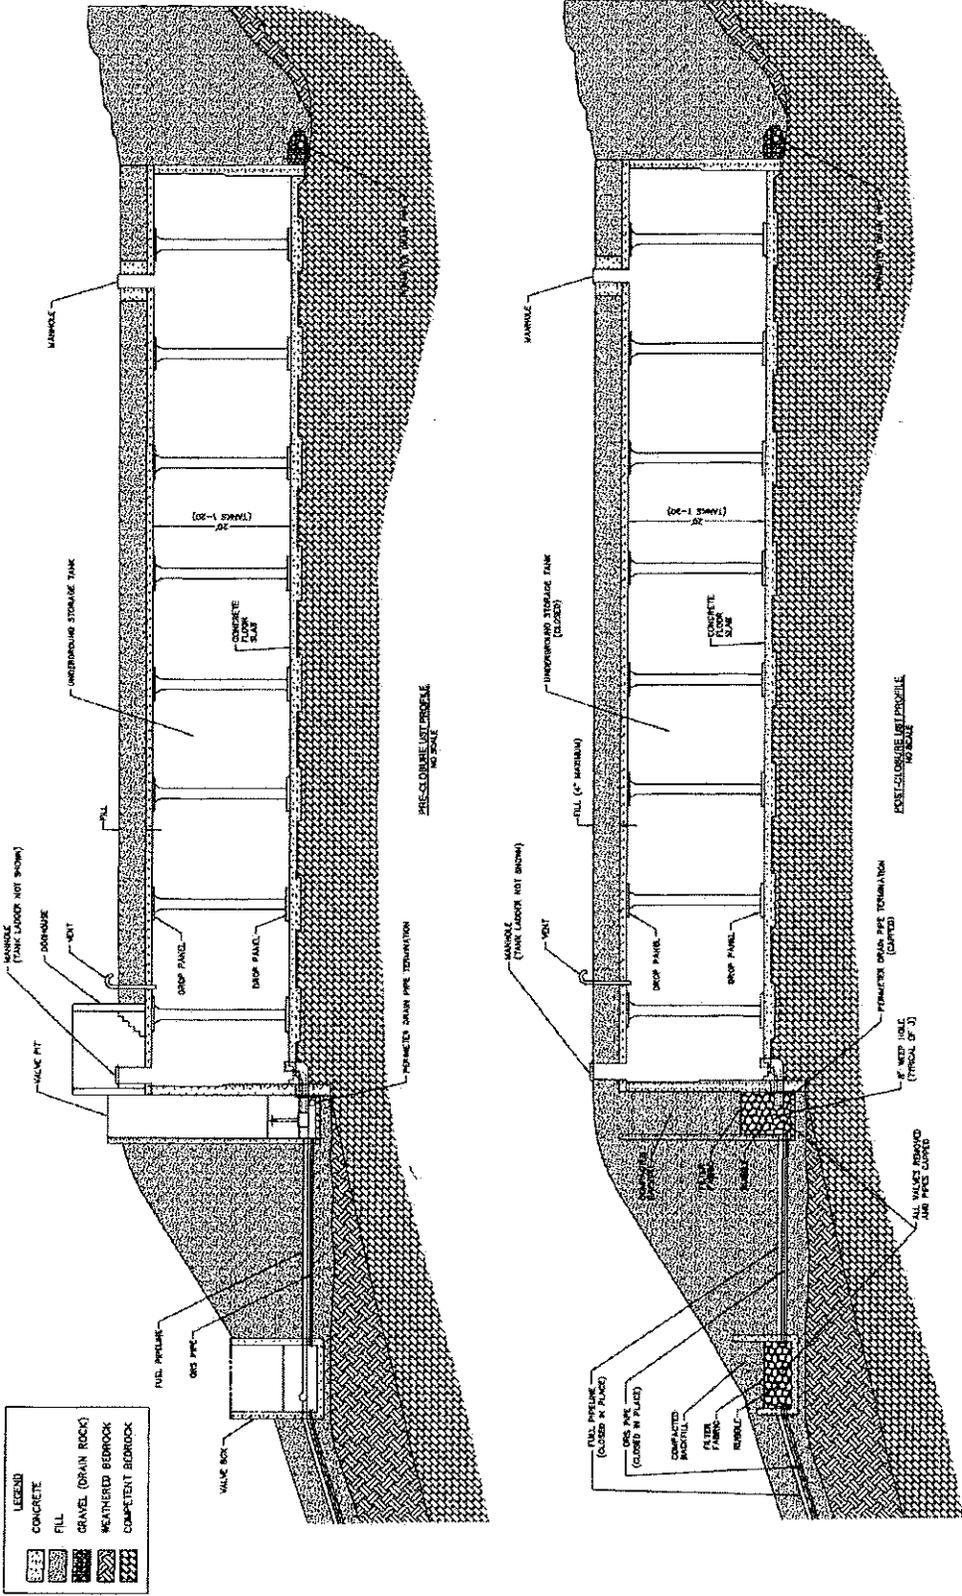
<b>SAFETY FIRST</b> 	CLIENT: City of Richmond	UST Cross Section
	PROJECT: UST Monitoring Report	
	PROJECT NUMBER: 0078.001.014	FIGURE 3

Each UST was constructed with a perimeter drain surrounding the tank bottom. Original design drawings indicate that each drain consisted of open joint tiles placed in a gravel bed. Each drain was laid on a slope to fall approximately 12 inches from the upper (uphill side) UST perimeter to the lower (downhill side) perimeter. Water collected by these drains was to the oil recovery system (ORS; TtEMI, 2002). The purpose of the perimeter drains was to prevent infiltrating surface water from accumulating in the backfill outside of the UST walls. Figure 3 is a typical cross section of a UST at former NFD Point Molate.

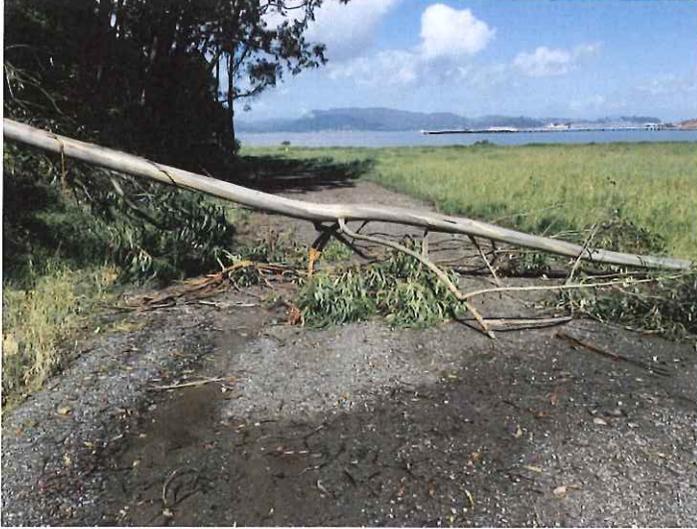
*Tree down on Diesel Road blocking access to Pier area.*

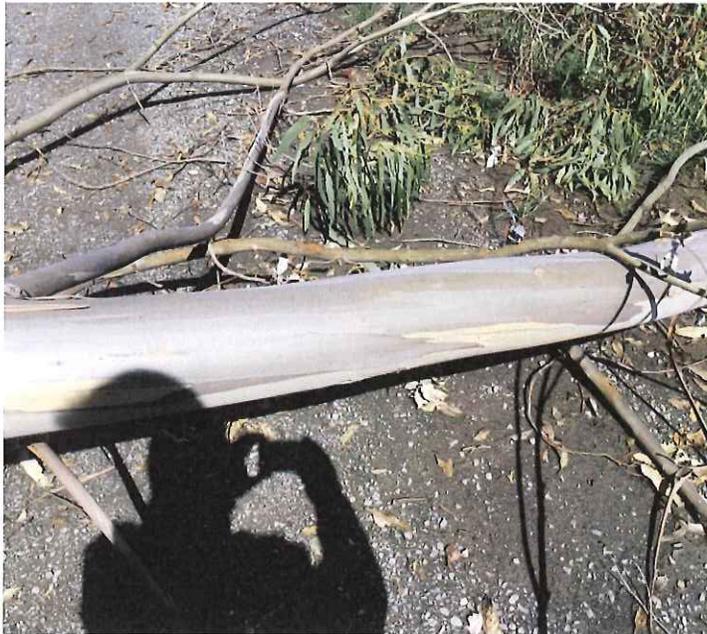
*Good sized Eucalyptus Sapling.  
Road. cleared by DIMO/Parks Staff Mark Maltagliati on Thursday April 27, 2017..*

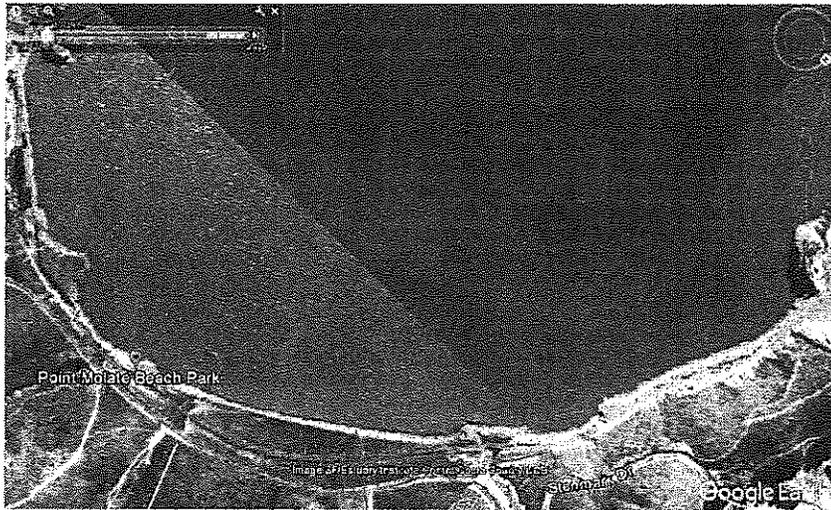
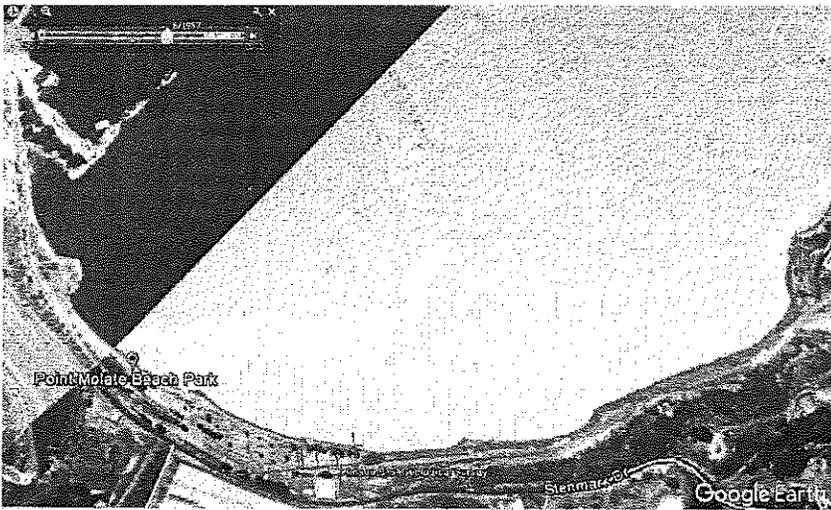
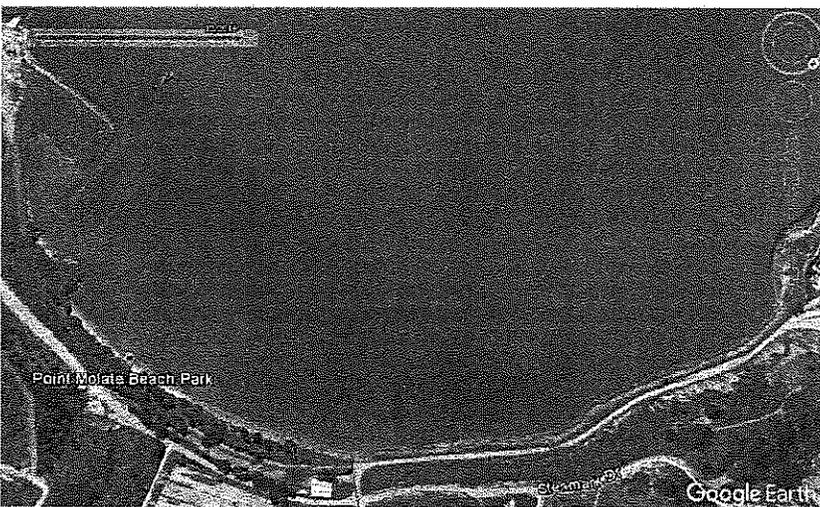
EXHIBIT 2

POINT MOLATE  
BEACH CONFIGURATION
