COASTLAND

Date: January 3, 2022
To: Andre Jadcowski, P.E., NCE
From: Jenny Melman, P.E.,
NASSCO PACP Cert. U-0819-70306761
Subject: City of Richmond
Keller Beach Sanitary Sewer CCTV Review
and Assessment Report

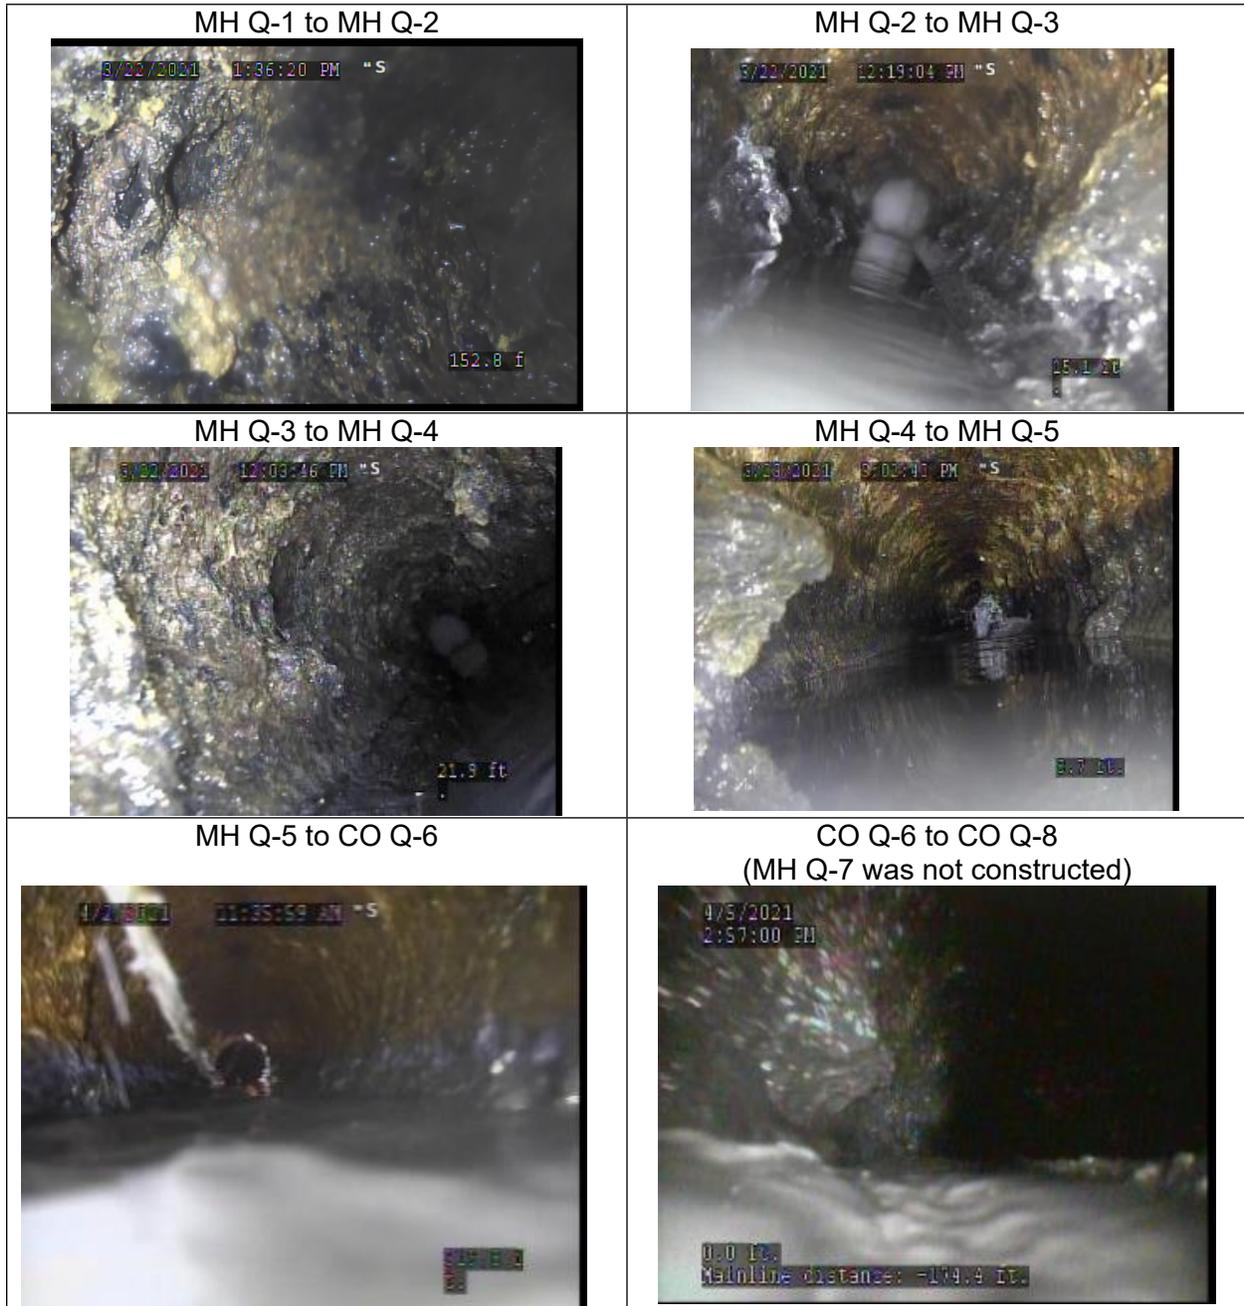
CO Q-8 to MH Q-9

According to Express Sewer, the entire reach of Keller Beach sanitary sewer was extremely corroded prior to cleaning. As shown in the post-cleaning images below, the upstream reach of pipe (MH Q-17 to MH Q-25) was generally descaled, while further downstream (MH Q-1 to MHQ-17) extensive turberculation and wall roughness remains.

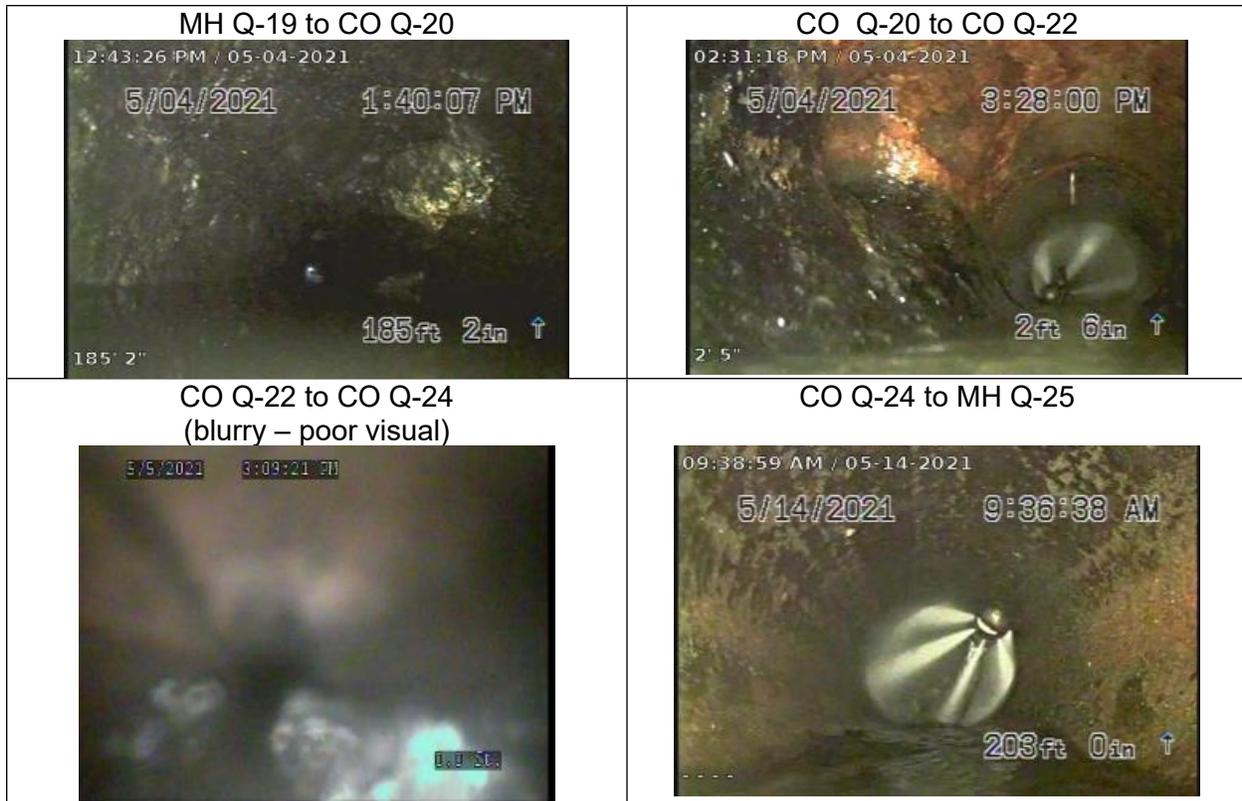
CO Q-18 to MH Q-19

No holes or cracks were observed in any segment (that was visible) of the Keller Beach sanitary sewer main, though the pipe walls show extensive evidence of pipe corrosion. Corrosion of the pipe walls (with a decrease of the pipe's structural integrity) has resulted over time due to the presence of corrosive hydrogen sulfide gas, a natural sewer gas, in the unlined pipe. The presence of extensive sags and pipe obstructions further exacerbate the problem by causing organic solids to settle and increases localized hydrogen sulfide gas production in the pipe. Corrosion will continue to deteriorate the pipe's structural integrity as long as the pipe remains exposed to sewage gases.
