# Standards for Restoration & Guidelines for Restoring Historic Buildings

## Standards for Restoration

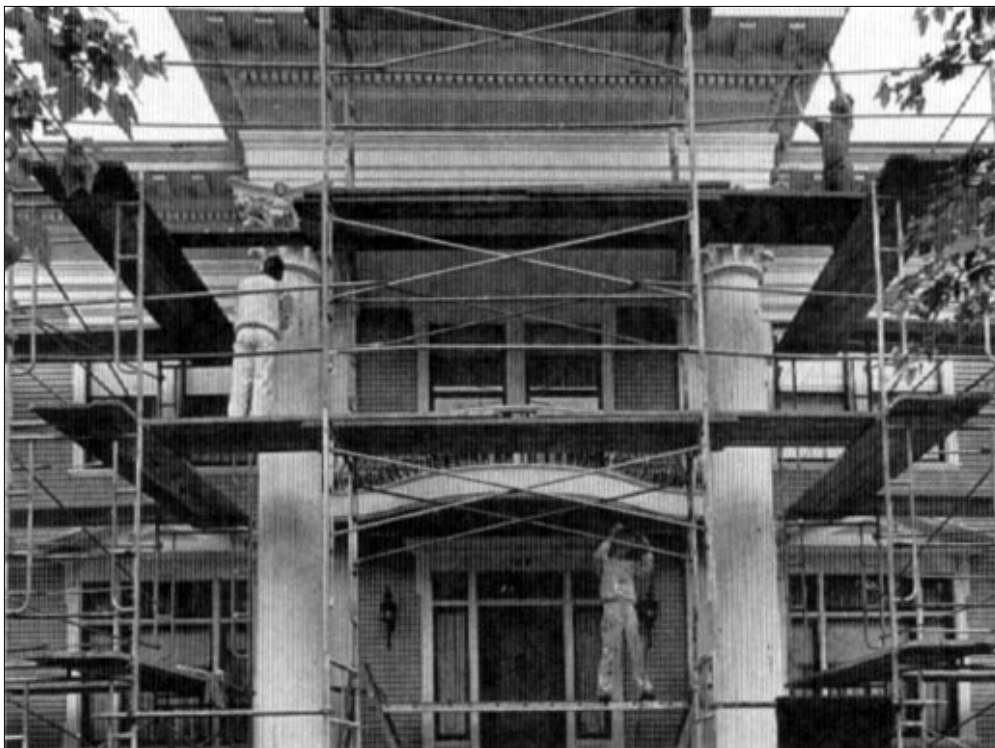
*Ongoing work at this house focuses on the maintenance and repair of exterior wood features from the restoration period. After scraping and sanding, the wood was painted in colors documented to the Restoration period. Photo: ©Mary Randlett, 1992.*

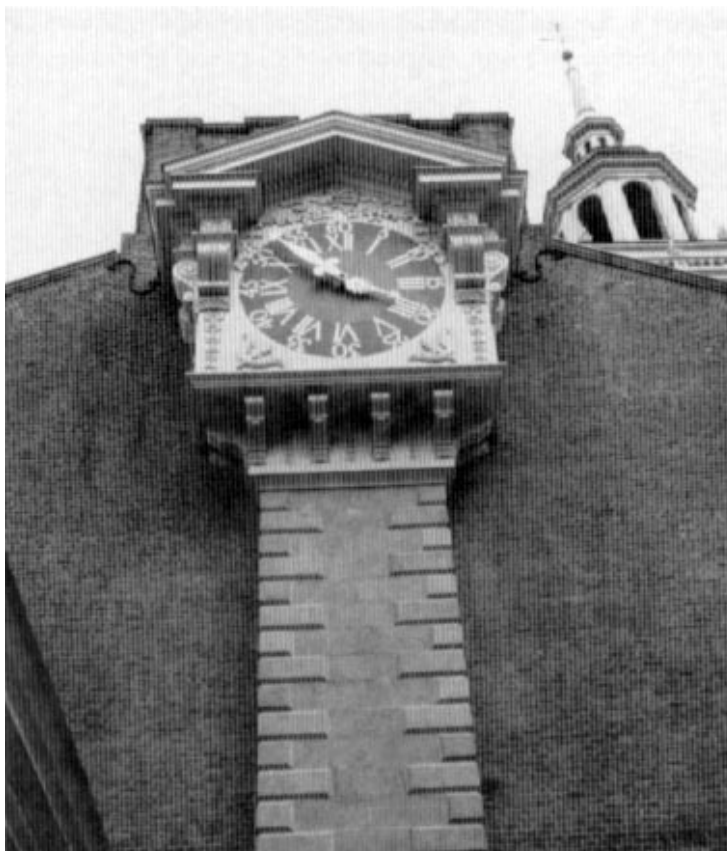
*The Standards for Restoration call for the repair of existing features from the restoration period as well as the re-creation of missing features from the period. In some instances, when missing features are replaced, substitute materials may be considered if they convey the appearance of the historic materials. In this example at Philadelphia's Independence Hall, the clock was re-built in 1972-73 using cast stone and wood with fiberglass and polyester bronze ornamentation. Photo: Lee H. Nelson, FAIA.*
