## 8.1 Berths 5-8 Condition Assessment Report

**POINT POTRERO MARINE TERMINAL  
BERTHS 5 TO 8 WHARF STRUCTURES CONDITION ASSESSMENT  
PORT OF RICHMOND**

**FOR MOFFATT & NICHOL**

**SITE VISIT DATE: MARCH 18 & 19, 2025**

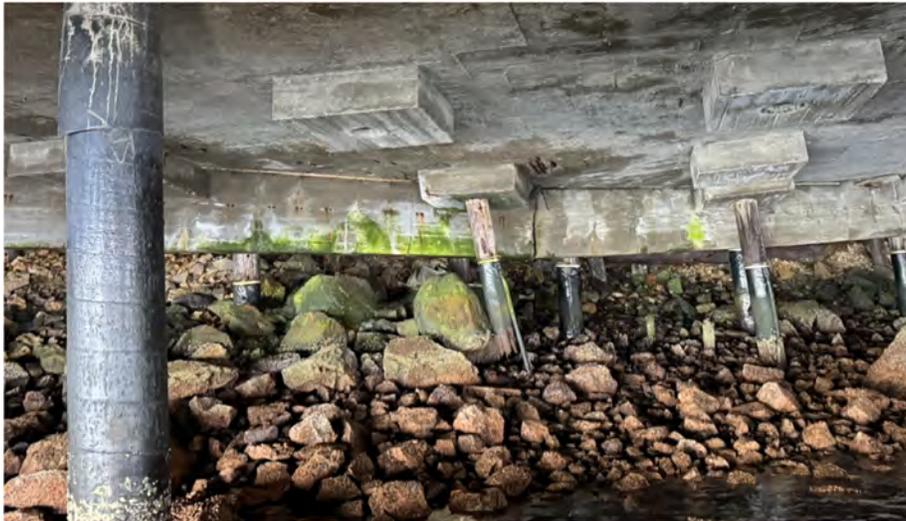
There is a significant large area of deck depression observed from above at the southern end of Berth 7. The deck depression was caused by a broken concrete beam at adjacent Berth 6 as shown in Photograph 1. All load should be removed from the depressed deck and over the beam. No construction equipment should be located near the break. This beam repair requires new piling, jacking, and grouting for leveling support.

Photograph 1: Broken concrete beam, damaged and missing timber piles

1. Cut holes at wharf deck for pile installation.
2. Install pile each side of the broken beams (3 locations as shown on Photo 1)
3. Install beam support plates.
4. Install jacking/support beams
5. Jack the beam and slab to level position using shim plates.
6. Remove jacks
7. Add non-shrink grout for permanent beam support.
8. Install concrete pier at missing and damage timber piles, See reference drawings 3/S3.6 (Sht. 5) for details. Assume 10 locations.
9. Repair deck reinforcing at holes and install grout or concrete.

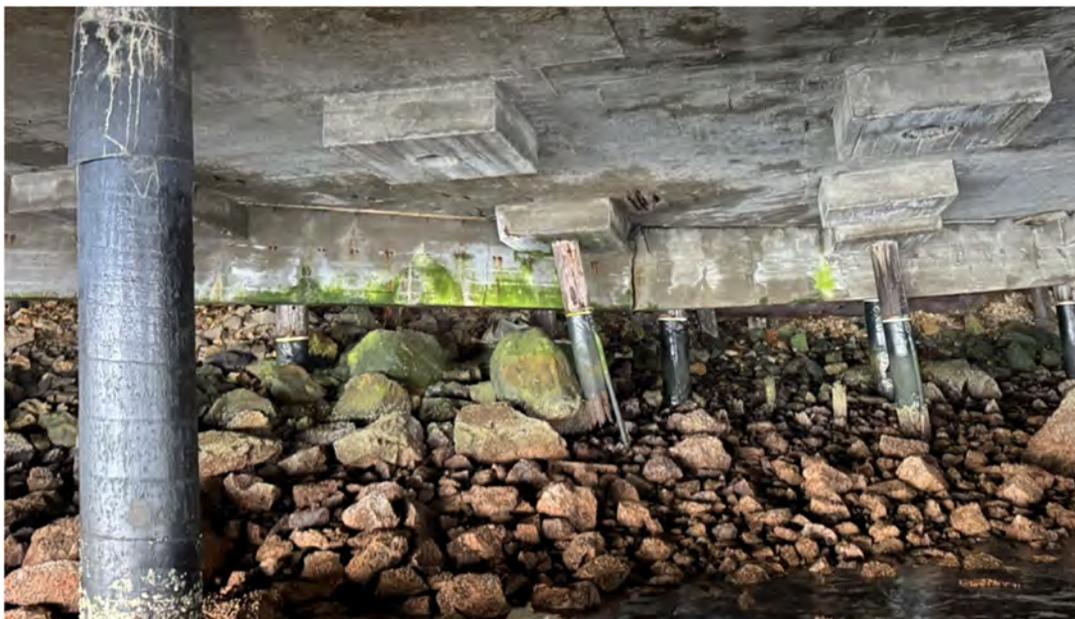
A major longitudinal concrete beam supporting the inner wharf deck is broken, resulting in excessive settlement observable from above deck. The timber piles supporting the beam are compromised. Additionally, there are missing piles and damaged timber piles in the adjacent bays, adding more weight on the beam. The loss of pile support caused it to be overloaded, to break, and to displace. The impact of this beam failure that occurred at Berth 6 extends to the southern end of Berth 7, which has deflected downward. This is observable from the above deck. See Photograph 4.

Photograph 4: Broken concrete beam, damaged and missing timber piles

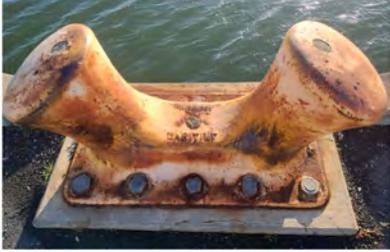
Moderate	Loss of coating and minor surface corrosion.  Concrete cracks at bollard base.
2010 Fender

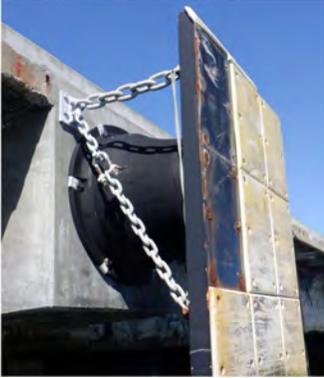
Moderate	Missing UHMW panels at several fender locations.  No damage observed at rubber fender cone.  Minor corrosion at some of the support chains.
Seismic Tie Beam Pavement Crack

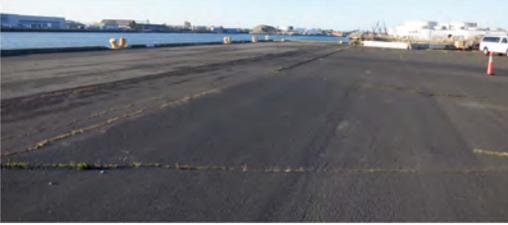
Major	Some of the seismic tie beams project to the wharf deck as pavement cracks indicating downward displacement of some of the seismic beams.

1. Cut holes at wharf deck for pile and beam installation.
2. Install pile each side of the deflected beams (4 locations per tie-beam as shown on plan. Total 4 - seismic tie beams)
3. Install beam support plates
4. Install jacking/support beams
5. Jack the beam and slab to a level position using shim plates.
6. Remove jacks
7. Add non-shrink grout for permanent beam support.
8. Perform corrosion damage repair for the concrete tie-beam.
9. Repair deck reinforcing at holes and install grout or concrete.
10. Repair corrosion damage at seismic tie-beam. Refer to reference drawing S3.3 for similar repair.

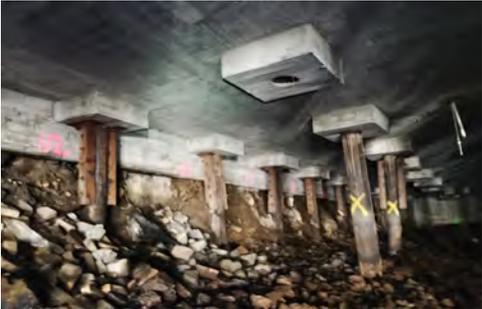
Severe	Many missing piles. Inner wharf. Mostly in Row F and under tiebacks. Also see Appendix D.
Sheet Pile Wall

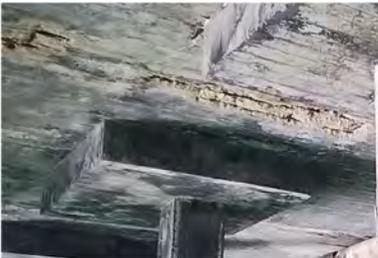
Major	Corrosion damage with loss of concrete cover (spalling) and exposed corroded rebars.

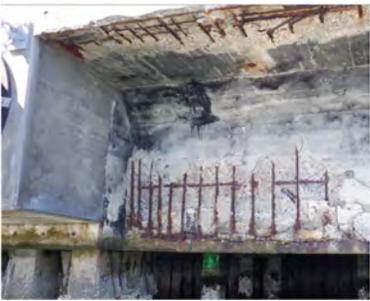
Major	Corrosion damage with concrete spalling and exposed rebar.
Expansion Joint Beam Damage

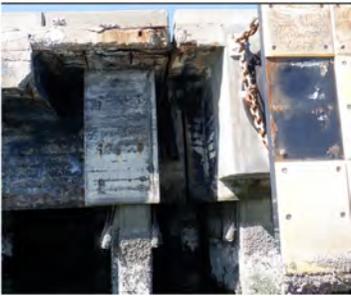
Major	Corrosion damage with concrete spalling and exposed rebar.

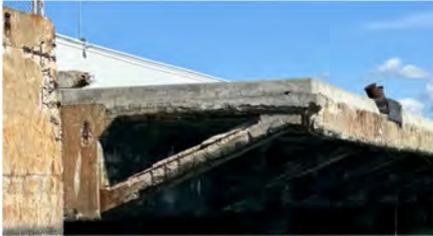
Major	Loss of concrete cover with exposed corroded rebars.  Concrete spalling at bottom deck.
Face Beam, Diagonal Strut, Soffit, and Waterside Crane Beam

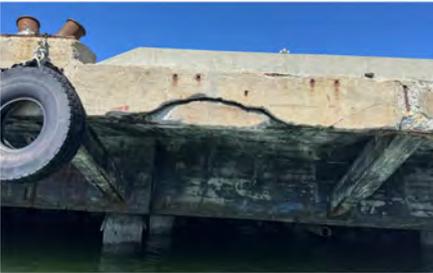
Major	Damaged face beam.  Corrosion damage with exposed corroded rebar at diagonal struts.  Concrete cracks and initial delamination at the bottom of the waterside crane beam.

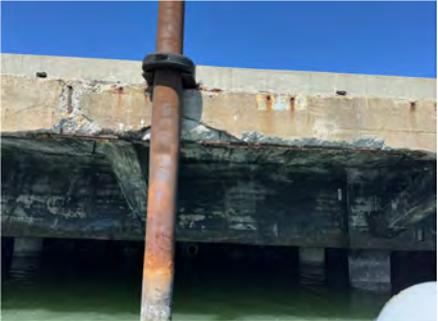
Major	Significant damage to the face beam, probably caused by vessel impact.
Spalled Beams and Struts

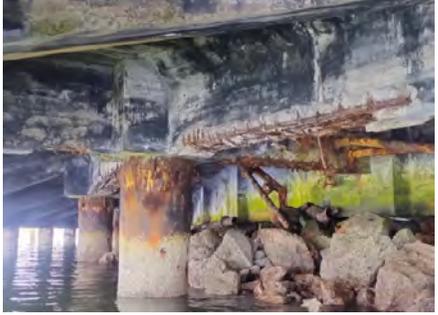
Major	Corrosion of concrete and rebar leading to spalling of beams and struts in multiple places. Outer wharf, Berths 5 and 6.

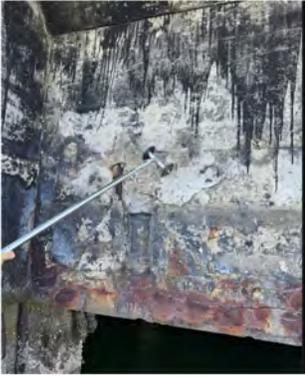
Major	Concrete cracks at the bottom of the crane girder and concrete delamination.
Inner Wharf – Timber Piles Supported Wharf

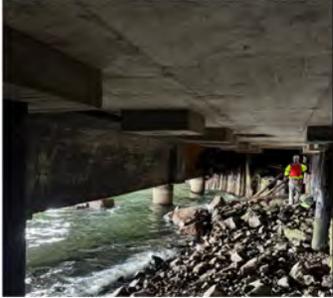
Severe	Berth 5 missing a row of timber piles (5 total). Also piles missing under Berth 6 inner wharf.

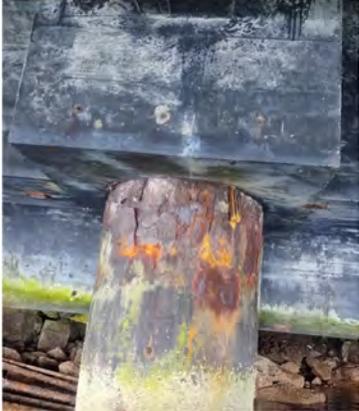
Major	Significant corrosion damage with wall thickness loss.

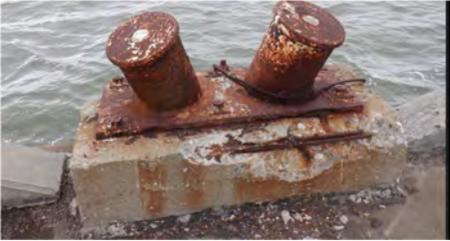
Severe	Significant corrosion damage at bollard bits and anchor bolts with spalled concrete base and exposed corroded rebars.
Top Deck

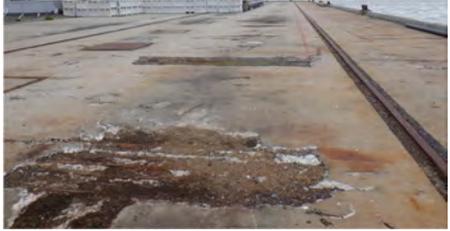
Major	Sections of the deck have corrosion damage with loss of concrete cover and exposed corroded slab rebars.  Some sections of the slab indicate concrete delamination.

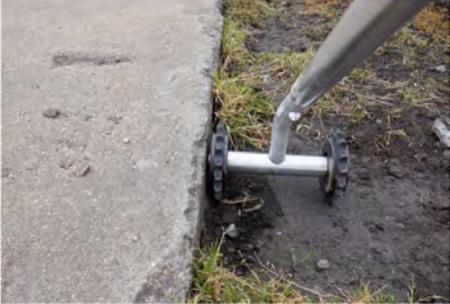
Major	Pavement settlement up to three (3) inches observed at the edge of the concrete deck.

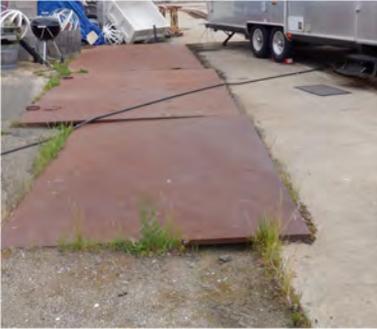
Major	Pavement failure covered with steel plates.

The pavement at the landside wharf edge has failed at several locations due to embankment erosion below. Refer to Appendix I for ENGEO's report for detailed clarification. This should be repaired by driving a steel sheet pile wall, backfilling, and repairing pavement.

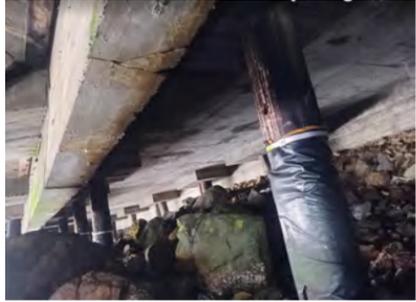
Space behind cracked beam

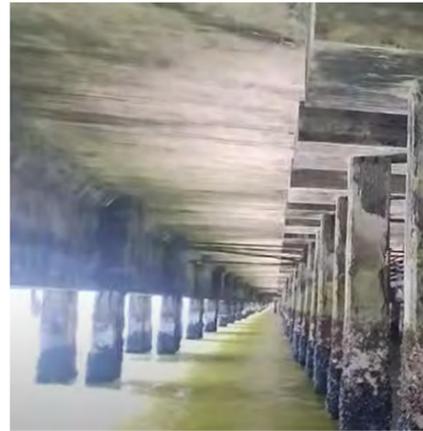
View looking South  
Soffit in good condition

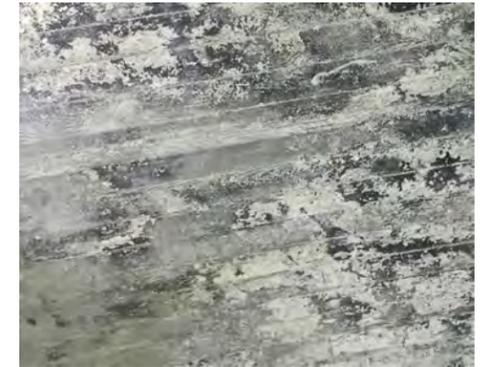
Example of soffit in  
good condition:

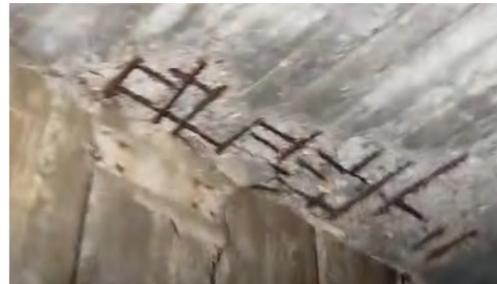
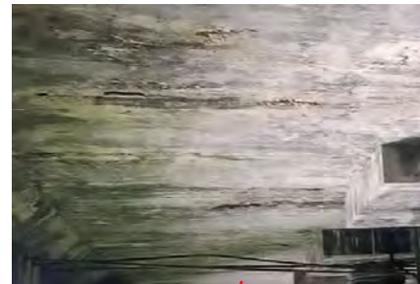
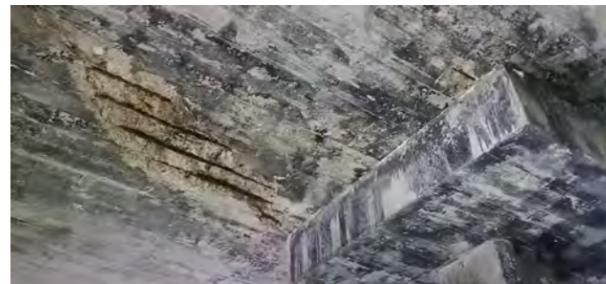
Spalled  
Concrete

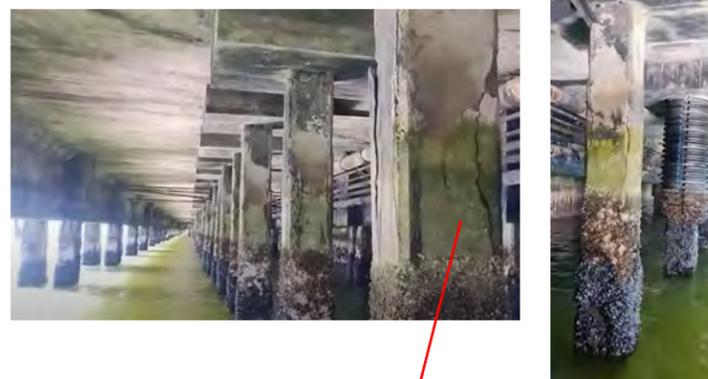
In general  
- Repaired piles in good condition  
- Many damaged piles

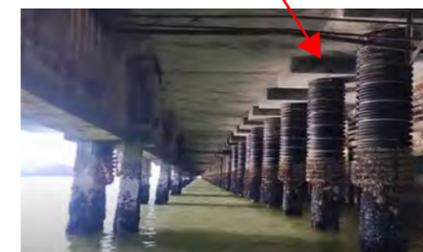
Repaired piles

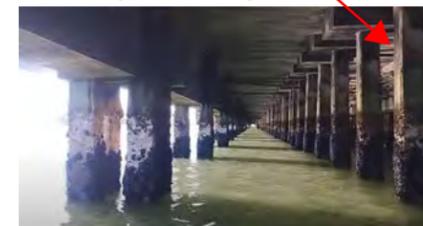
Unrepaired piles

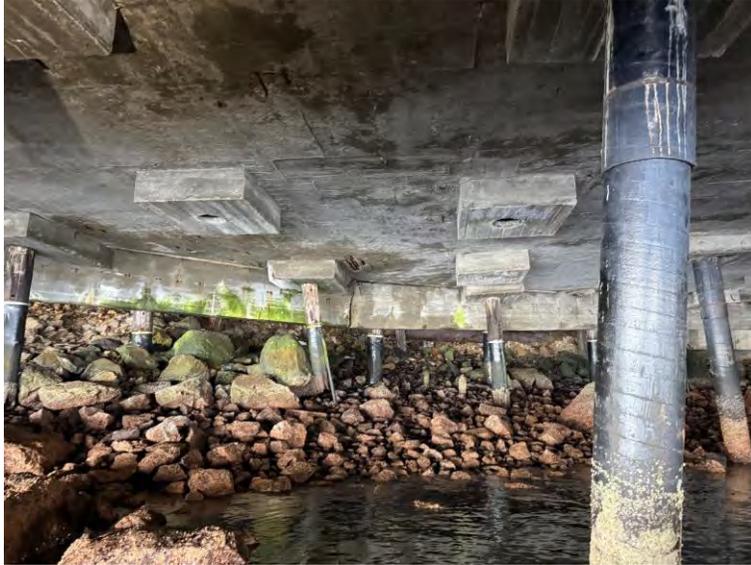
**EXHIBIT 1: Area of Settled Wharf – Berth 6**

Along much of the wharf, there is a headwall at the interface of the wharf structure and the land. However, in the area of the settled pavement at Berth 5, there is no headwall, and the soil/weathered bedrock appears to be eroding at the top of the slope below the wharf (as shown in Exhibit 2). In this area, we recommend creating a confinement structure at the top of the slope to retain and protect fill from erosion and backfilling the area of lost ground so the pavement can be restored and stabilized.

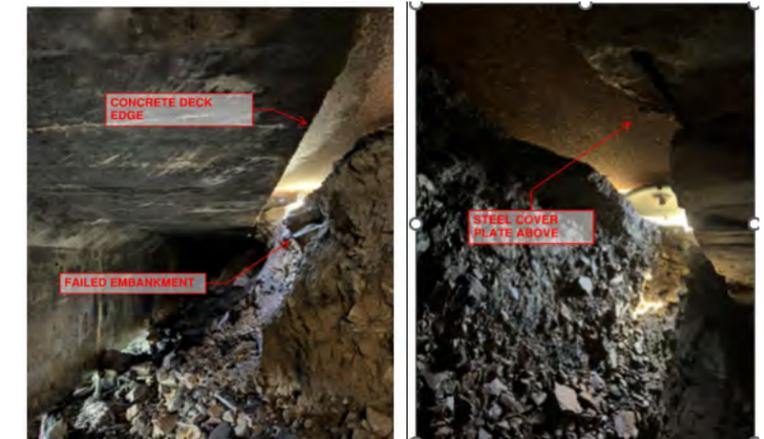
On 05/18/2025, a site inspection was performed below deck at Berths 5 & 6, it was noted that the soils/weathered bedrock eroded at the top of the slope causing significant pavement settlement. Refer to ENGEO report (Sheet 2 to 3) for a detail description and recommendation.

Photo 1 - Below Deck, Erosion and Pavement Failure

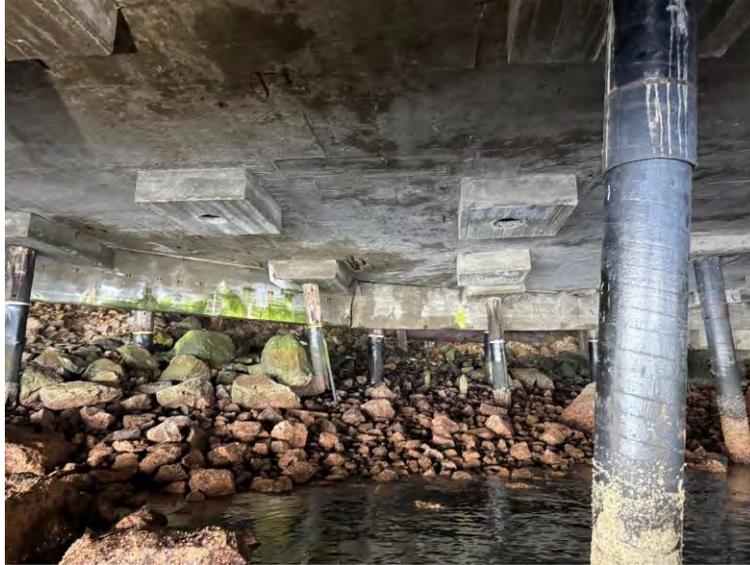
**EXHIBIT 1: Area of Settled Wharf – Berth 6**

On May 19, 2025, we performed an inspection below the deck of Berths 7 and 8 with Liftech. We performed this inspection between the existing sheet pile wall and the landward slope. We entered the area through manholes in the deck; Power provided assistance with access and site safety monitoring. During our inspection, we again observed stable slope conditions below the wharf and no evidence of pile plunging. Again in areas where pavement settlement was observed at the interface between the land and the wharf, this appeared to be due to erosion of the top of the slope in areas without a headwall; in one area this lack of wall appeared to be due to utility penetration and the eroded soil was likely utility trench backfill. We recommend a similar fix in this area.

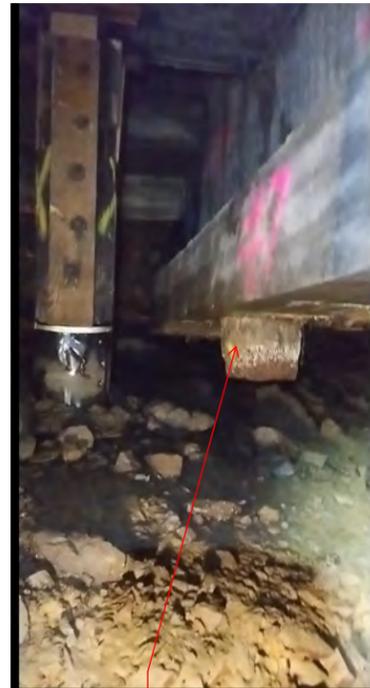
Missing piles

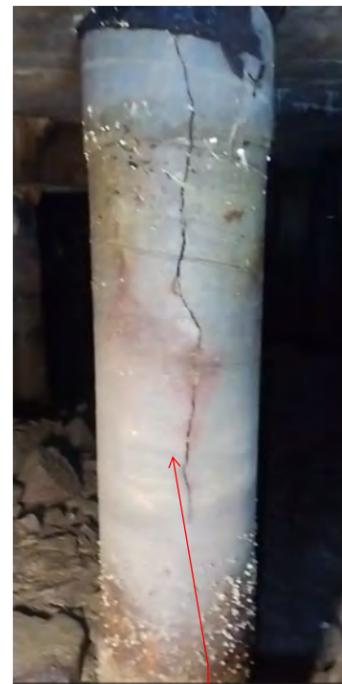
Pile overstressing

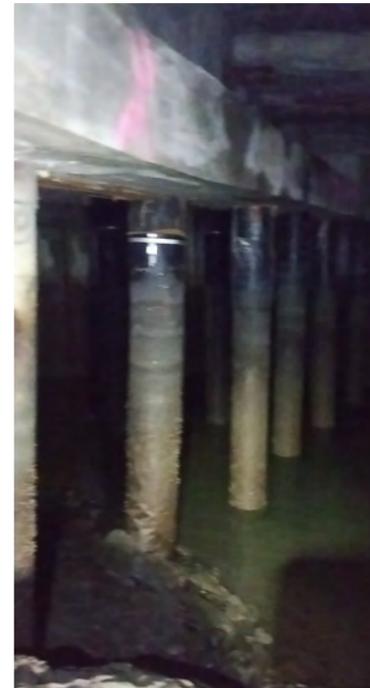
Seismic tie projected to pavement surface. Some settlement observed

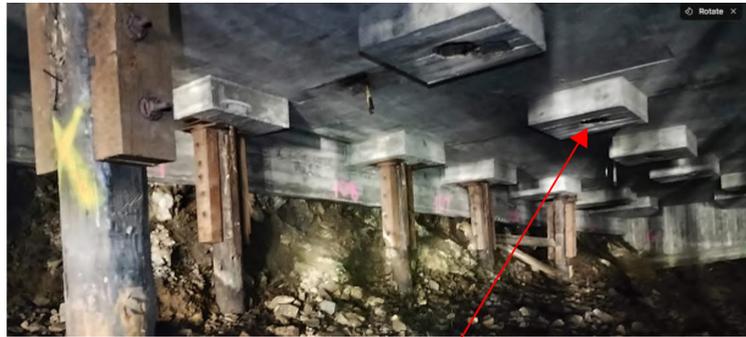
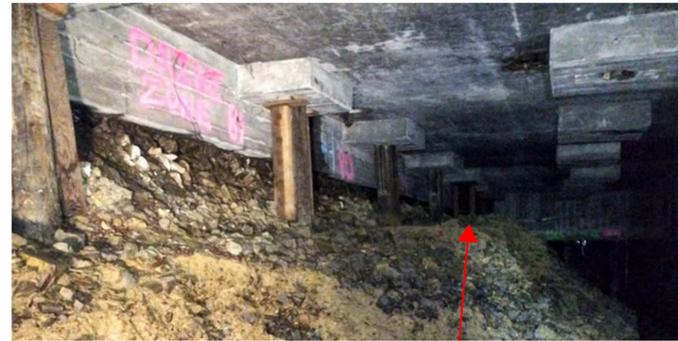
Nearly entire row of piles missing between tie-backs

Piles circled in red were repaired in 2010 project. Typical.

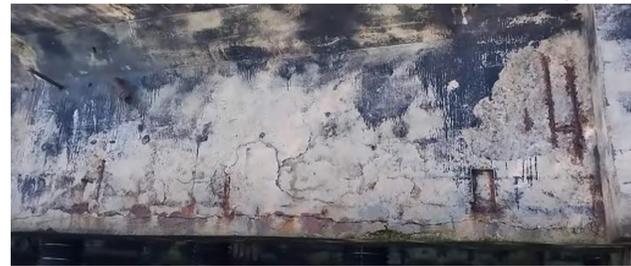
Delamination and Spalling Concrete near Wharf Face

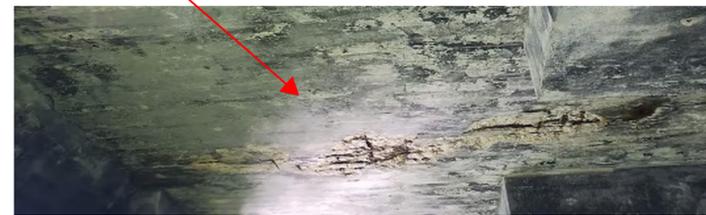
Delamination and Spalling Concrete at Soffit

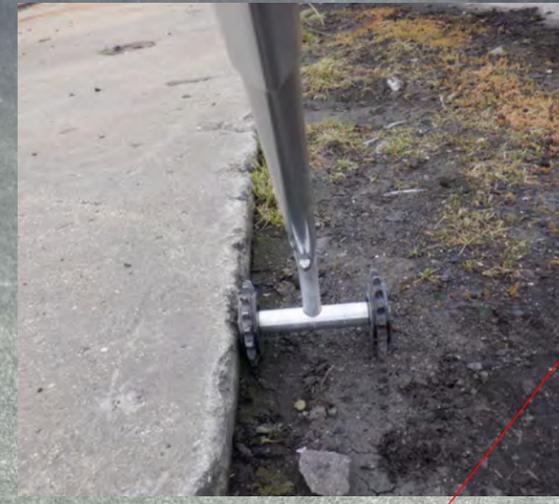
Pavement Settlement

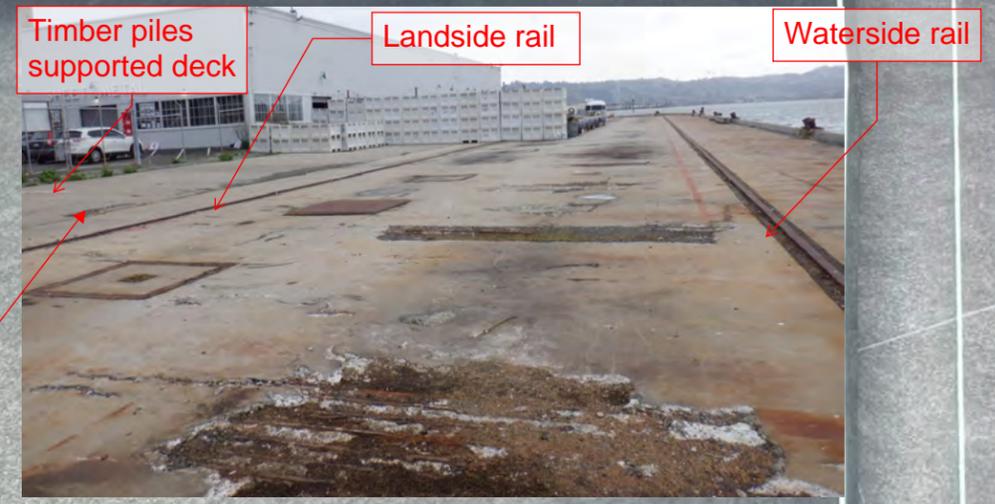
Timber piles supported deck

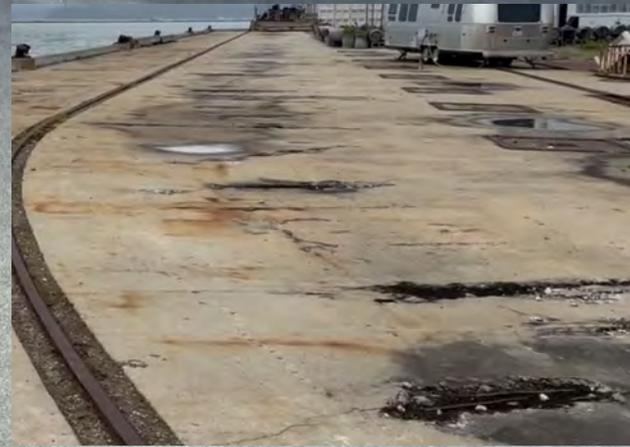
Concrete Deck Condition

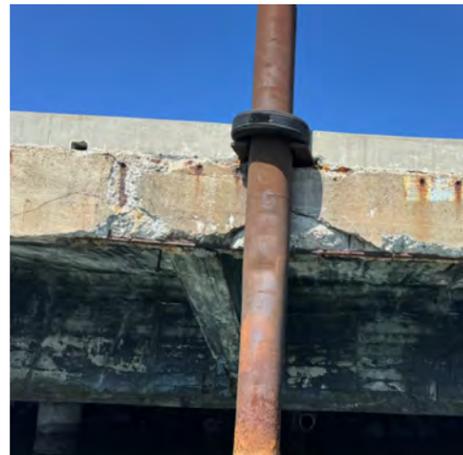
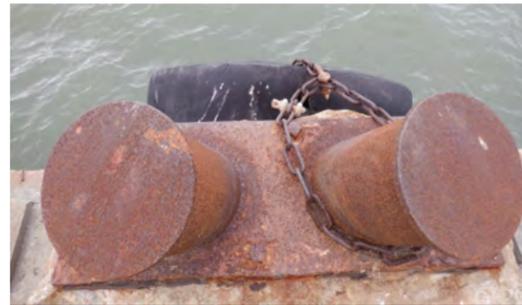
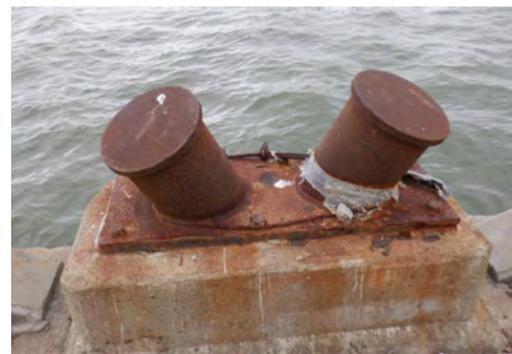
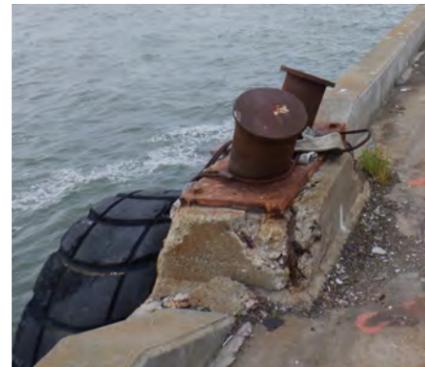
Photos Showing Current Fender and Bollard Conditions at Berths 5 & 6

1. Demo existing bollards and fenders
2. Install three discrete fenders at Berth 5. Refer to reference drawing S2.02 on sheet 5
3. Install two discrete fenders at Berth 6
4. Install five bollards at Berth 5 with strengthened beams, equally spaced. Refer to reference drawing S5.01 on sheet 6
5. Install four bollards at Berth 6 with strengthened beams, equally spaced.
